SAFEHULL SYSTEM FOR BULK CARRIERS

GUIDE ON IMPROVEMENT FOR STRUCTURAL CONNECTIONS AND SAMPLE STRUCTURAL DETAILS —SERVICE EXPERIENCE AND MODIFICATIONS— FOR BULK CARRIERS

OCTOBER 1995

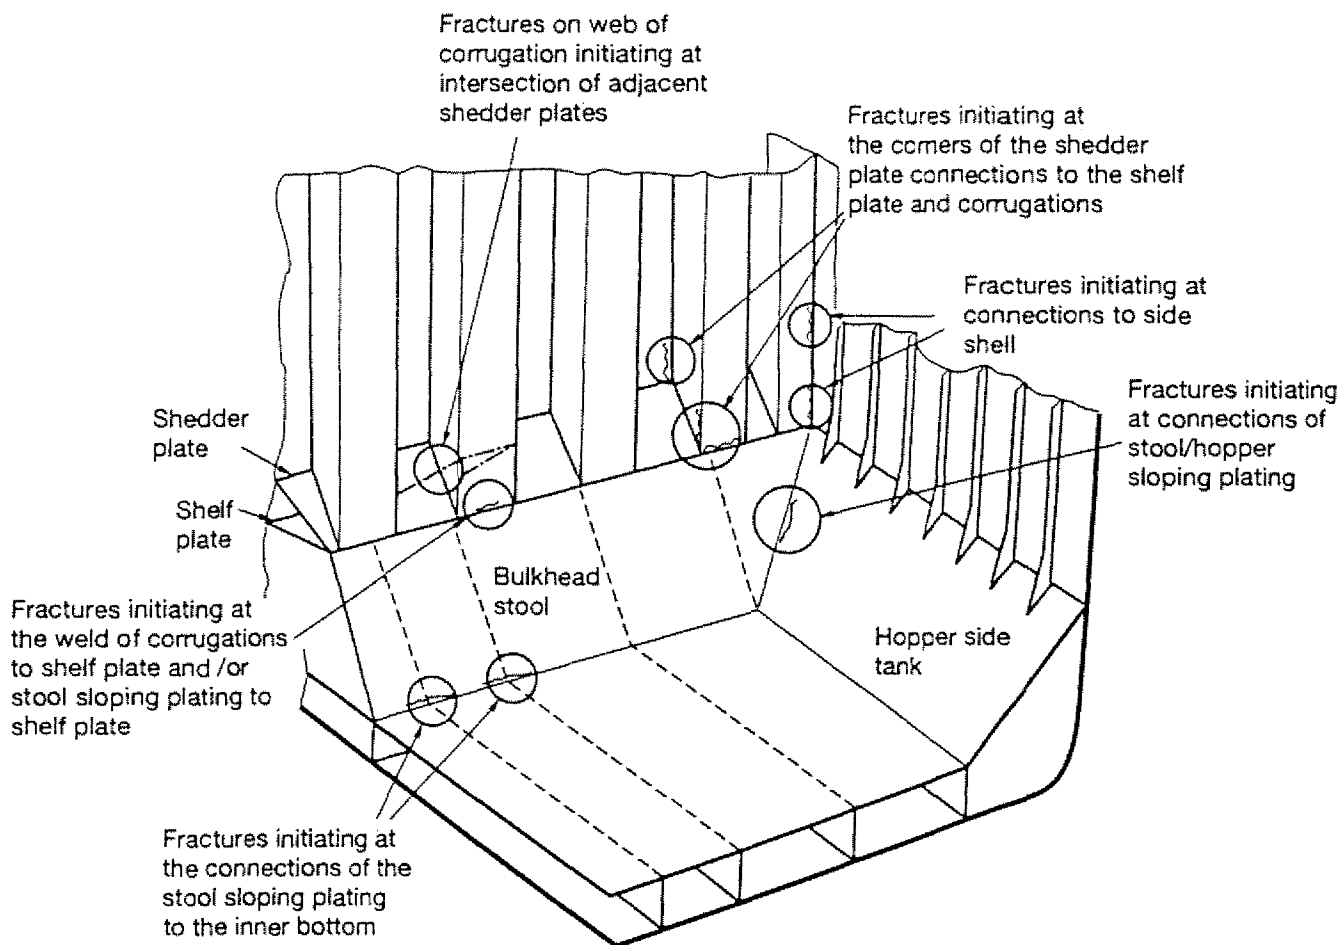
(Similar damages may occur at the upper connections of the bulkhead to the deck structure)

Figure 2 Typical Fracturing at the Connection of Transverse Bulkhead Structure

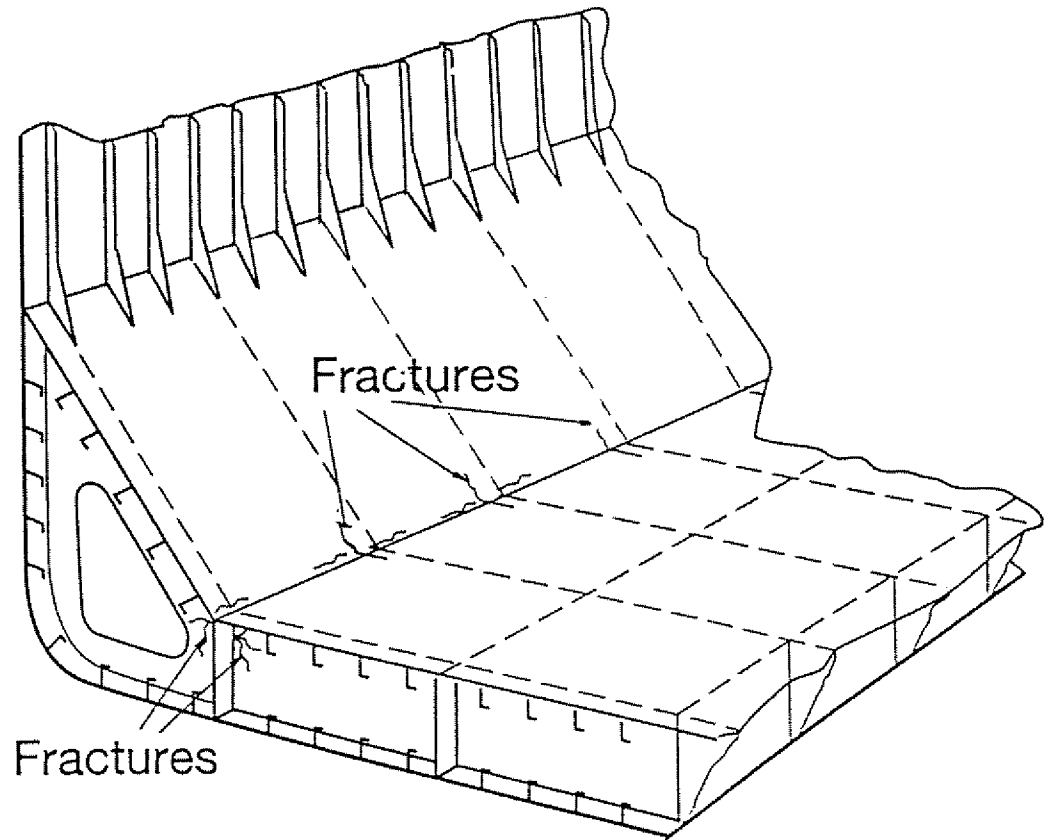
Sample damaged structural details and connections are illustrated in Figures 3a thru 3h for double bottom structures. Attention should be paid to the weld connections of the slope longitudinal bulkhead and the inner bottom plating.

Figure 3 Typical Fractures in the Connection of Hopper Plating and Tanktop/Inner bottom

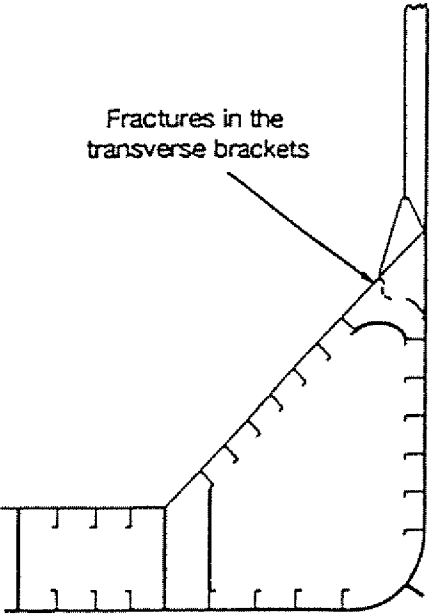
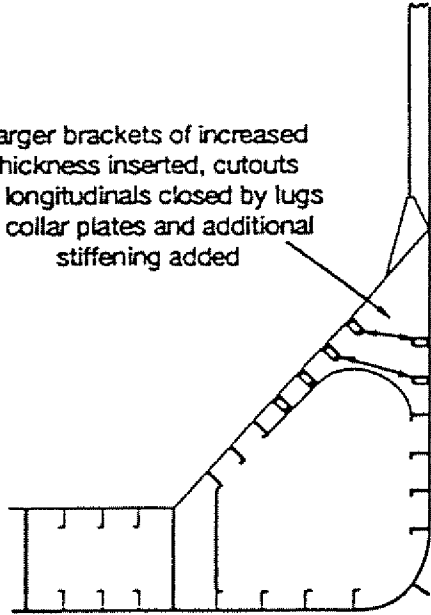
Figure 4b

Detail of damage	Fractures at weld connection of the transverse brackets
<p data-bbox="175 619 386 651">Sketch of damage</p>

<p data-bbox="326 917 548 974">Fractures in the transverse brackets</p> <p>The sketch shows a cross-section of a hopper tank structure. A vertical longitudinal member is on the right, and a sloped transverse member is attached to it. The transverse member is supported by brackets. Dashed lines indicate fractures at the weld connections between the transverse member and the brackets.</p>	<p data-bbox="813 619 1003 651">Sketch of repair</p>

<p data-bbox="862 932 1219 1081">Larger brackets of increased thickness inserted, cutouts for longitudinals closed by lugs or collar plates and additional stiffening added</p> <p data-bbox="841 1491 911 1523">Note :</p> <p data-bbox="841 1555 1409 1676">If the damage is caused by misalignment with the frame bracket above, the misalignment is to be rectified and the replacement by a bigger bracket incorporated only if felt necessary.</p> <p>The repair sketch shows the same structure as the damage sketch, but with thicker brackets, lugs or collar plates closing the cutouts in the longitudinal member, and additional stiffening added to the structure.</p>

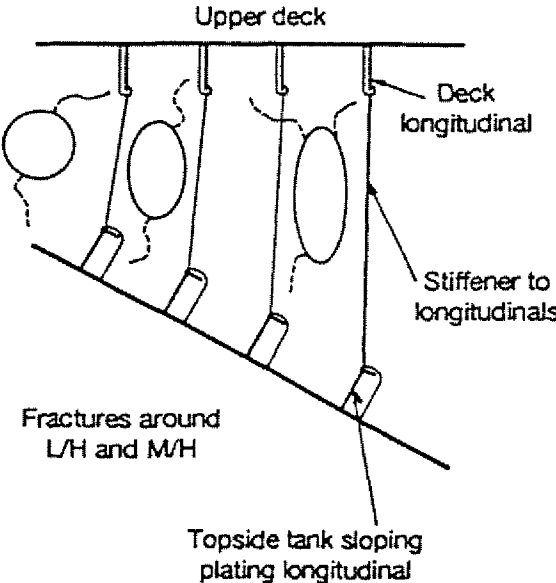
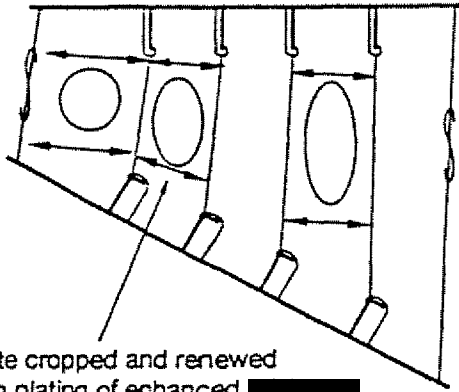
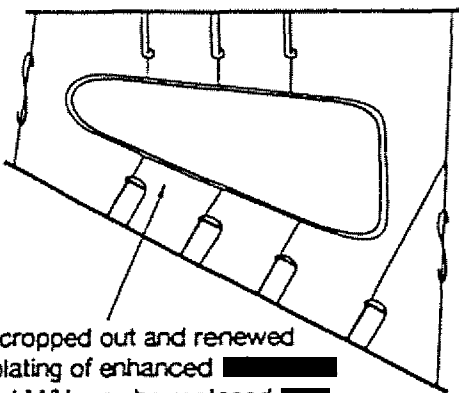
Figure 5a

<p>Detail of damage</p>	<p>Fractures around unstiffened L/H and M/H in wash bulkhead</p>
<p>Sketch of damage</p>

<p>Upper deck</p> <p>Deck longitudinal</p> <p>Stiffener to longitudinals</p> <p>Fractures around L/H and M/H</p> <p>Topside tank sloping plating longitudinal</p>	<p>Sketch of repair</p> <p style="text-align: center;">Repair (a)</p>

<p>Plate cropped and renewed with plating of enhanced [redacted] and horizontal stiffeners [redacted]</p> <p style="text-align: center;">Repair [redacted]</p>

<p>Plate cropped out and renewed with plating of enhanced [redacted] L/Hand M/H may be replaced [redacted] cut-out as shown and incorporating [redacted] plate to form a transverse [redacted] in accordance with the relevant [redacted] Society Rules</p>
