Discussion Paper

Designing Means of Access and Related Access Aids

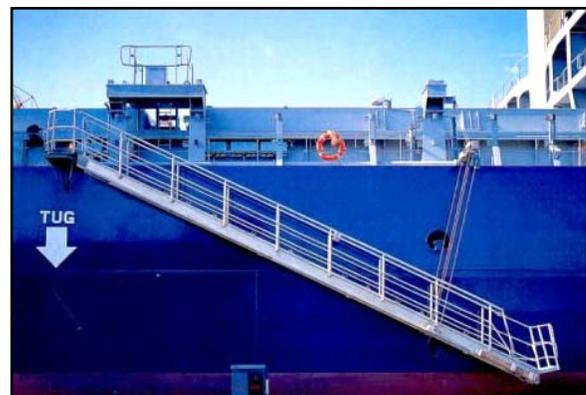
Traditional maritime design practices allowed for stairs of up to 60° inclination. However, as the angle of inclination of stairs increase, the stair tread gets narrower and the riser height increases. This in turn decreases the amount of tread available to step on, especially during descent, thereby increasing the likelihood of a crew member's foot slipping from, or missing, a step.

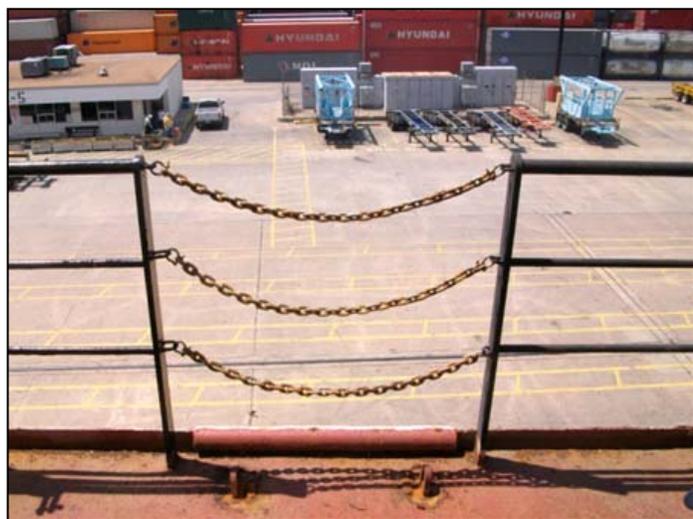
Handrail heights for safety at deck edges can vary depending on what ship design standard is selected. Design dimensions have traditionally accommodated the lower limit required, 39 inches (1000mm); however, it has recently been recommended that 39 inches (1000mm) is insufficient. The general opinion of safety engineers is that the lower limit is no longer adequate to deter falls over a

rail for the 95th% male, especially those from the Northern European and North American regions. At the lower limit, it is judged more likely for taller crew members to rotate over the rail, as the center of mass (for a 95% Northern European and North American male) is about three inches higher than the height of the rail.

When the center of mass of a human body acts above a guardrail, a person falling against that guard rail will have a greater tendency to rotate over the top of the railing. Further, when the center of mass of a human body acts below the top of a rail that person would have a tendency to rotate under the railing. This action (rotating under the top rail), along with the provision of intermediate rail(s), helps prevent a fall either over or under the top safety rail.

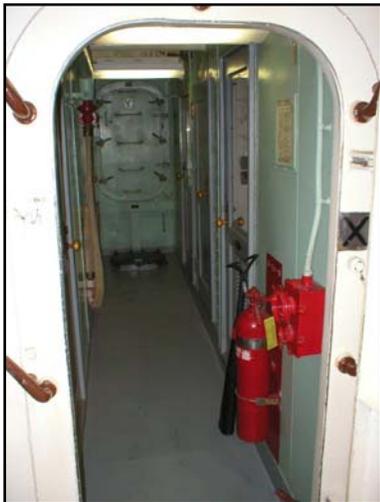
A major concern related to the simple task of walking down a passageway is the presence of bulkhead mounted equipment. Items mounted on a bulkhead, such as an electrical junction box or a fire hose box and fittings, present safety hazards. Further, it is advisable that passageways be kept free of any bulkhead-mounted objects if a passageway has any of the following characteristics (Zohar, 1978):

Where minimum widths are offered in walkway and passageway design standards they define the minimum clear walking surface. This is different than the dimensions of the walkways or passageway bulkheads with a walking area impeded by items mounted on walkway or passageway bulkheads. There should be suitable upper clearance for items mounted on a walkway or passageway bulkhead to prevent a person from accidentally walking into these items (Zohar, 1978).
