ABS REGULATORY NEWS

No.05/2022

PERMANENT MEANS OF ACCESS (PMA) – INSPECTION & MAINTENANCE

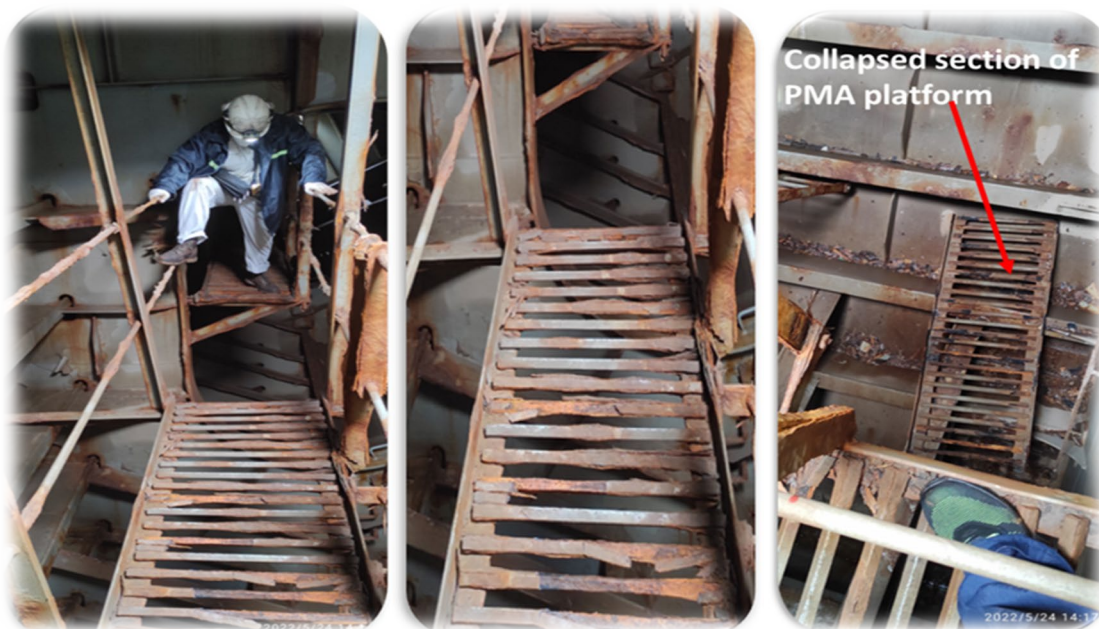
In May 2022, ABS attended a 10-year-old Bulk Carrier in drydock for the progression of Special Survey Hull # 2. The attending Surveyor, with the vessel's Chief Officer, entered the # 6 Top Side Wing Water Ballast Tank from the main deck access opening and descended onto the upper PMA platform. Shortly thereafter, an entire section of the platform collapsed underneath the Surveyor and Chief Officer (Figure 1). Fortunately, no serious injuries were sustained as both persons held on tightly to the handrails and were able to make their way safely back to the access ladder and leave the tank.

Figure 1. Collapse of PMA platform during inspections on 10-year-old Bulk Carrier.

In cargo holds, cargo tanks and ballast tanks, the PMA can be subject to rapid deterioration due to the corrosive environment of bulk cargoes carried, and the external forces from ship motions and sloshing of liquid contained in tanks.

It is of critical importance that safety is not compromised or overlooked. The near miss, as previously detailed, highlights the dangers of a lack of maintenance and inspection of the PMA.

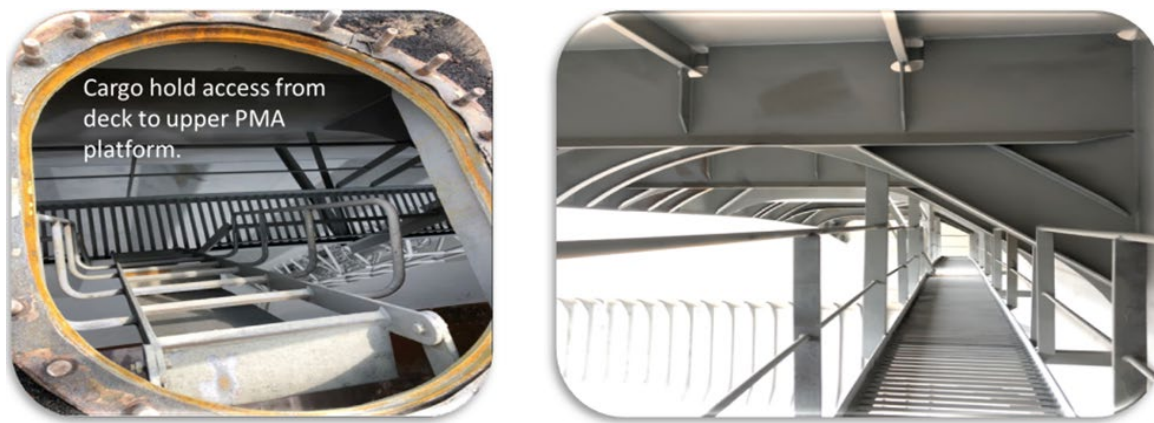
Figure 2. Deck access and upper platform on a 5-year-old vessel.

In recognizing the serious wastage, corrosion and deformation in cargo hold upper PMA platforms as shown in the above figures, ABS investigated further into the regulatory requirements of PMA with respect to maintenance and inspection. SOLAS Chapter II-1/3-6 and IACS Rec. No.90 identify the following:

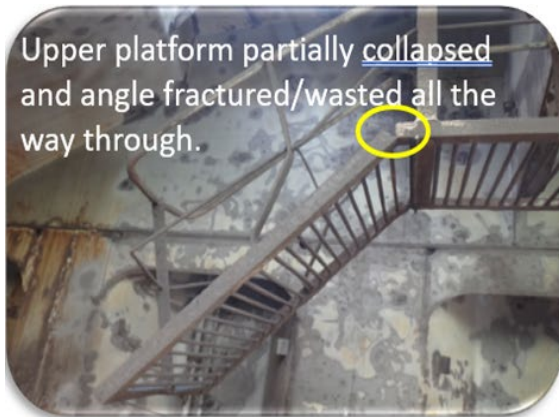
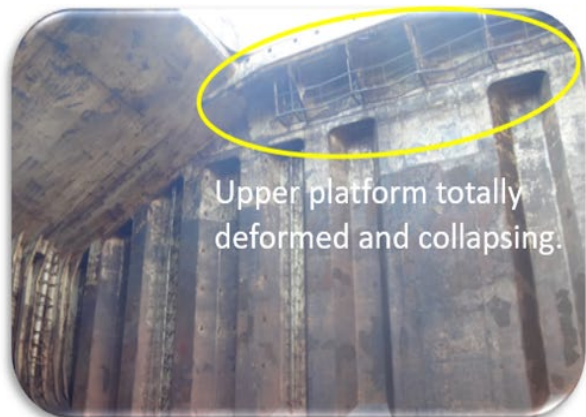
Figure 4. Deck access and upper platform on a 10-year-old vessel.

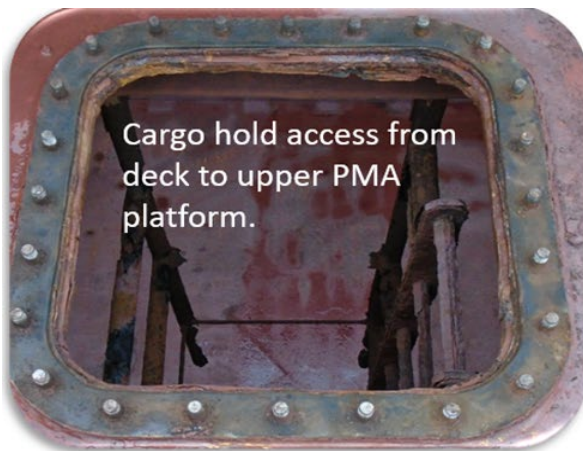
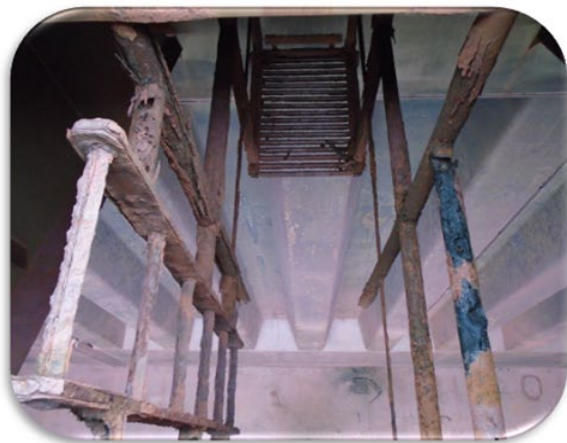
Figure 4. Deck access and upper platform on a 10-year-old vessel.

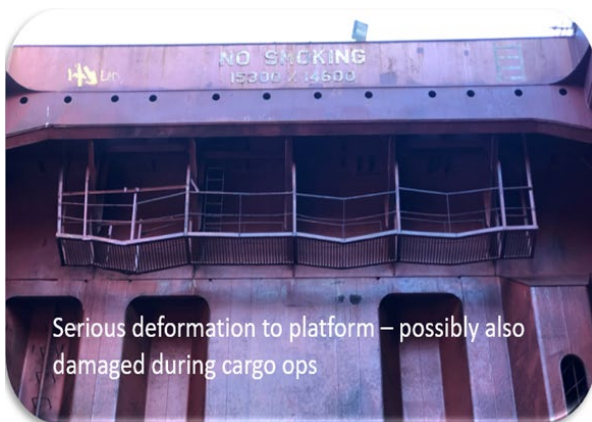
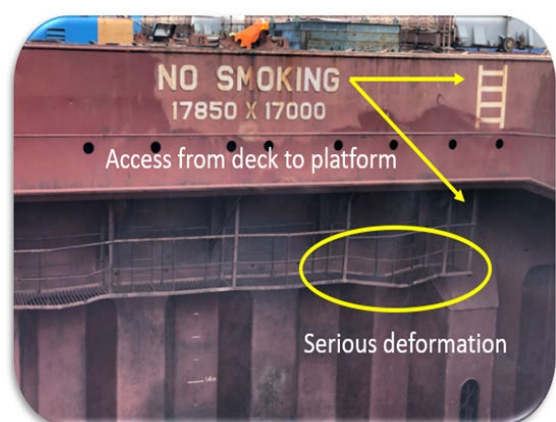
Figure 3. Deck access and upper platform on a 15-year-old vessel.
