SAFEHULL SYSTEM FOR BULK CARRIERS

GUIDE ON IMPROVEMENT FOR STRUCTURAL CONNECTIONS AND SAMPLE STRUCTURAL DETAILS —SERVICE EXPERIENCE AND MODIFICATIONS— FOR BULK CARRIERS

OCTOBER 1995

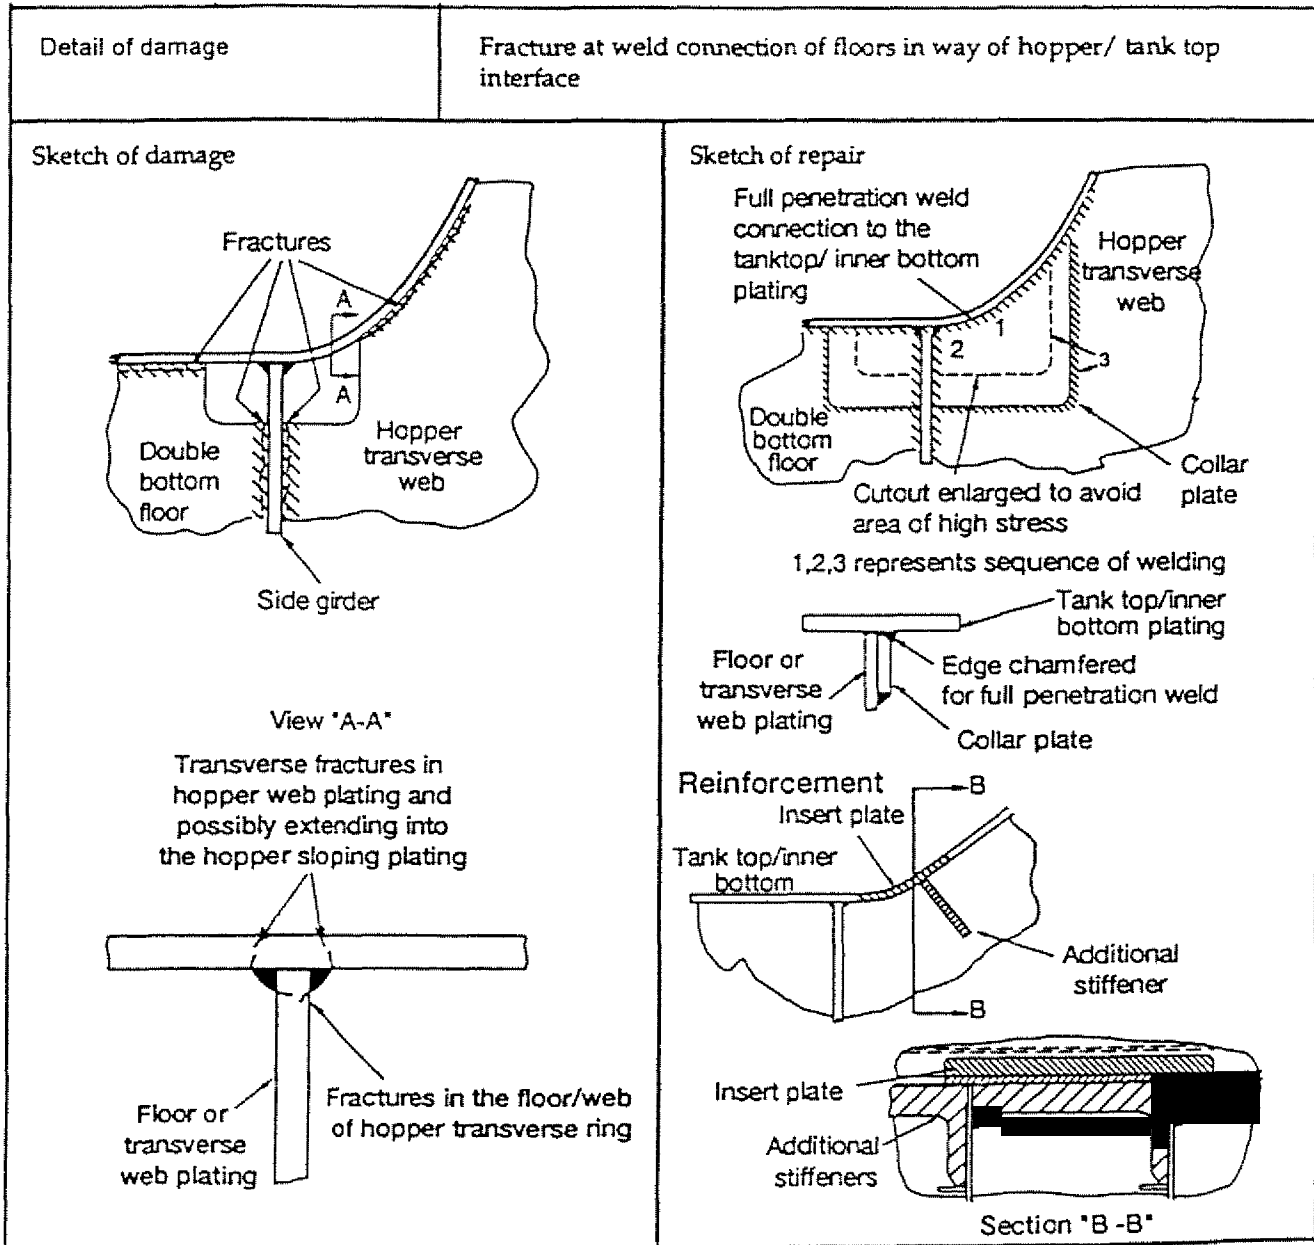
Figure 3a

Sample damaged structural details and connections are illustrated in Figures 3a thru 3h for double bottom structures. Attention should be paid to the weld connections of the slope longitudinal bulkhead and the inner bottom plating.

Figure 3 Typical Fractures in the Connection of Hopper Plating and Tanktop/Inner bottom
