USER MANUAL
Tug-Barge
Combination

RAPID
RESPONSE
DAMAGE
ASSESSMENT

March 2019

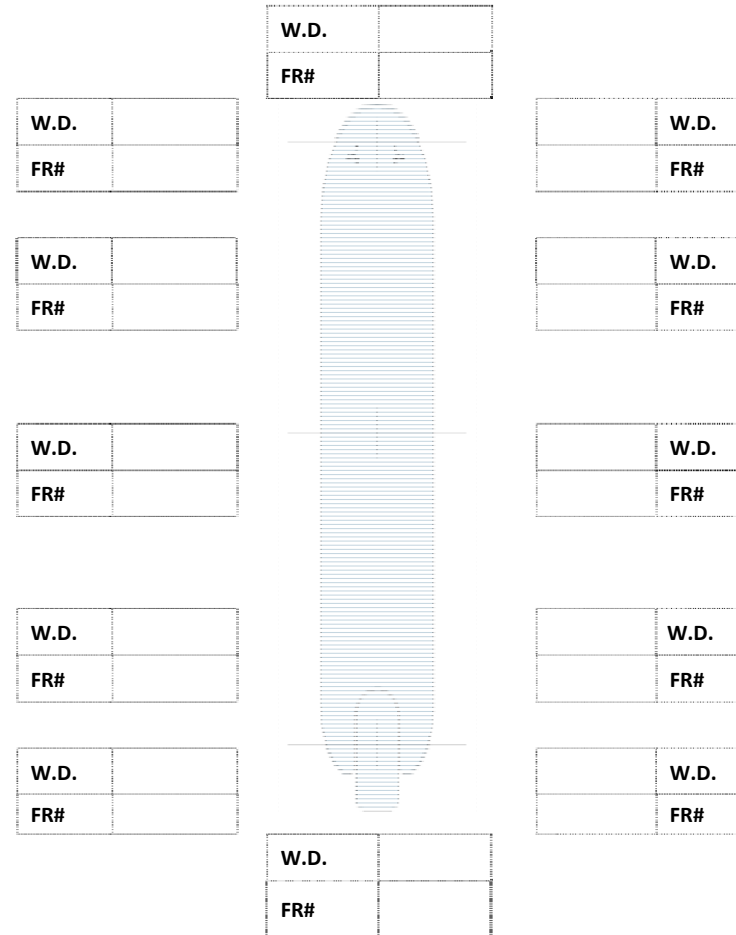
Additional Details About a Grounding Incident

The diagram shows a vertical hull outline with a dashed centerline. It is surrounded by data entry boxes for water depth (W.D.) and FR# at various points along the hull.

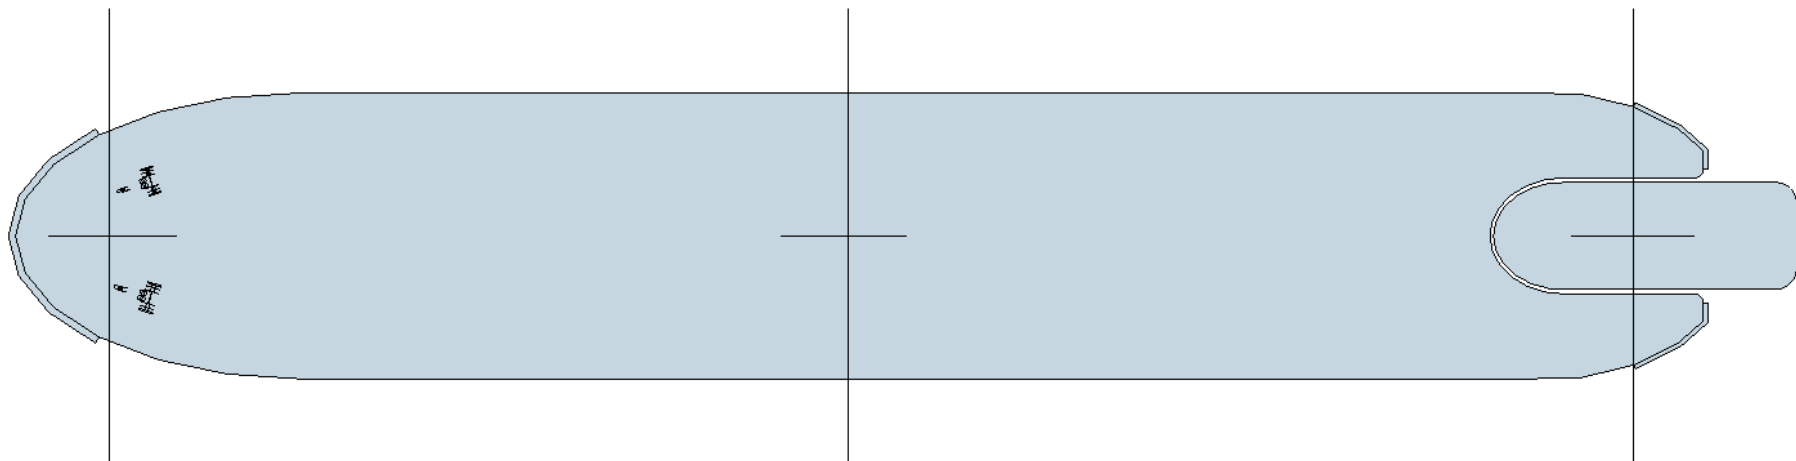
USE THIS DIAGRAM TO ILLUSTRATE ANY ADDITIONAL PERTINENT INFORMATION LIKE GROUND CONTACT AREA, PINNACLES, AREA DAMAGED, BUCKLING or CRACKS, HULL BREACH, WATER DEPTHS, FREEBOARDS, DRAFTS, OBSTRUCTIONS, ETC.

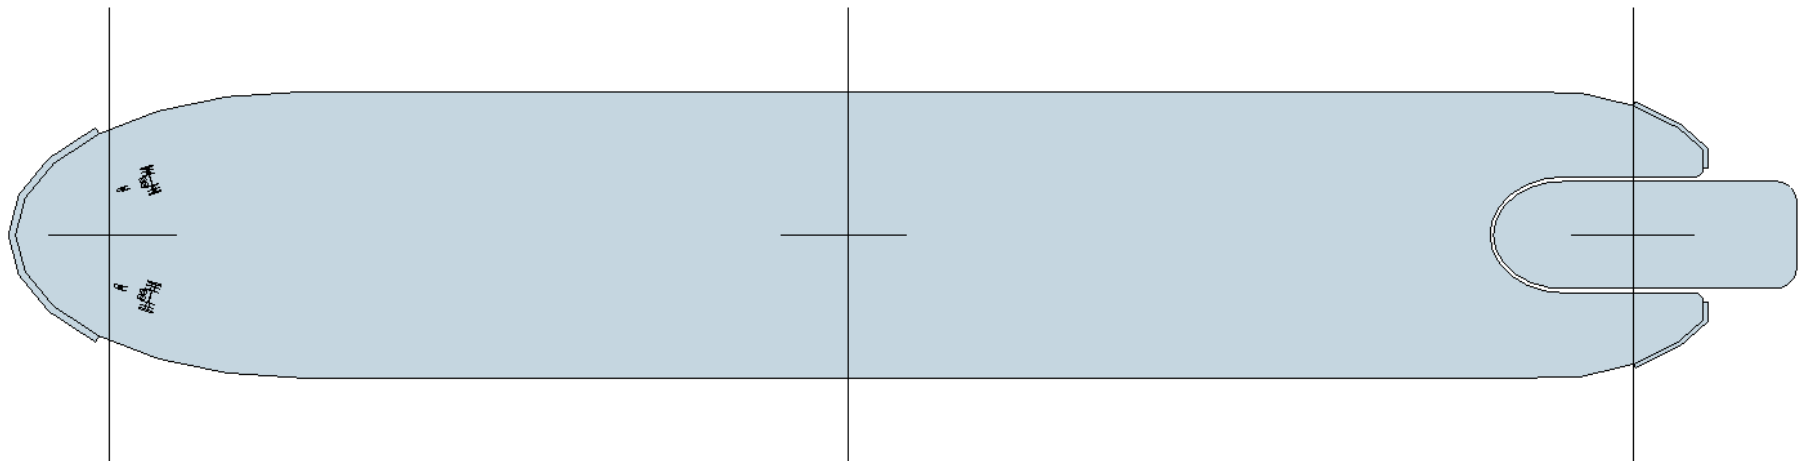
USE THIS DIAGRAM TO ILLUSTRATE ANY ADDITIONAL PERTINENT INFORMATION LIKE GROUND CONTACT AREA, PINNICLES, AREA DAMAGED, BUCKLING or CRACKS, HULL BREACH, WATER DEPTHS, FREEBOARDS, DRAFTS, OBSTRUCTIONS, ETC.
