USER MANUAL – GAS CARRIER

RAPID RESPONSE DAMAGE ASSESSMENT

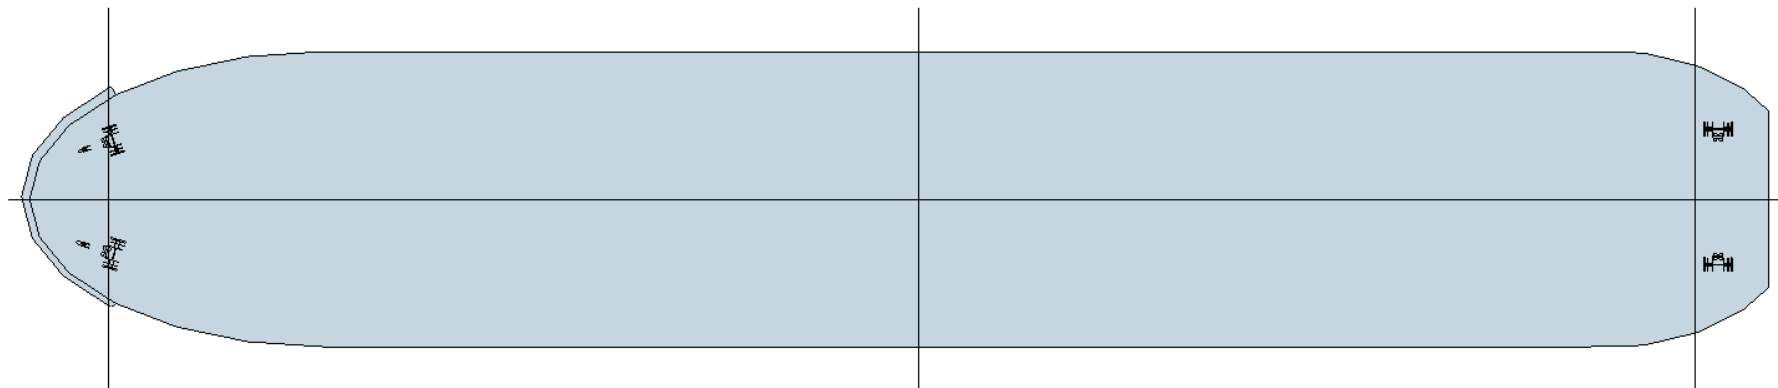
USE THIS DIAGRAM TO ILLUSTRATE ANY ADDITIONAL PERTINENT INFORMATION LIKE GROUND CONTACT AREA, PINNACLES, AREA DAMAGED, BUCKLING or CRACKS, HULL BREACH, WATER DEPTHS, FREEBOARDS, DRAFTS, OBSTRUCTIONS, ETC.
