USER MANUAL –
TANKER

RAPID
RESPONSE
DAMAGE
ASSESSMENT

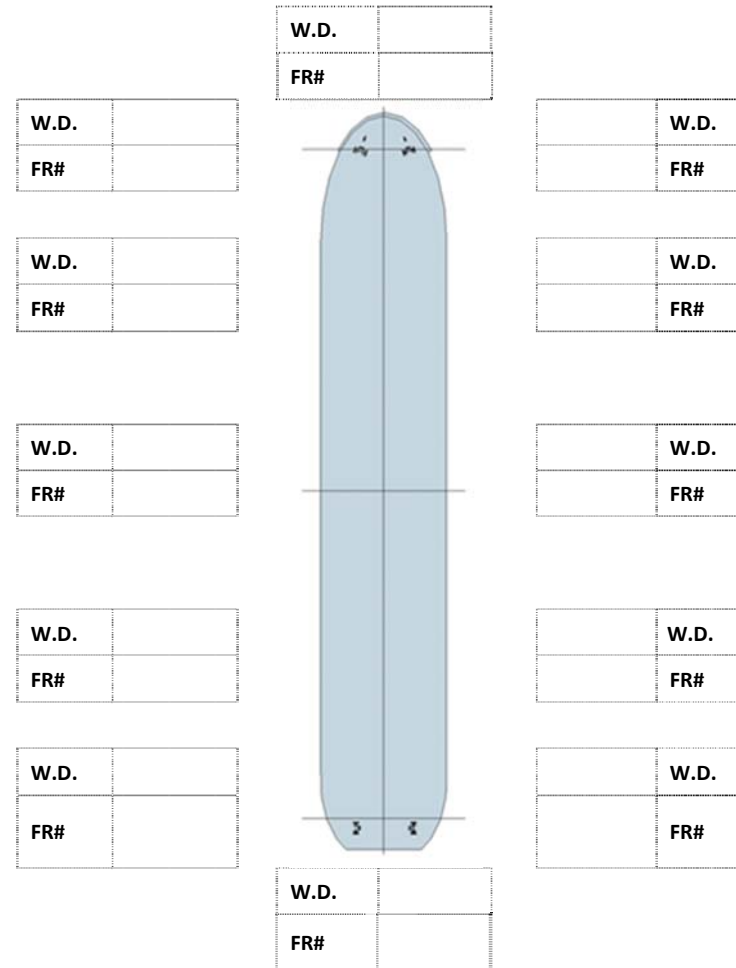
Additional Details About a Grounding Incident

Vessel Name:			
Date:			
1. Drafts - Aground			
Units	Meters	Feet	
Time	-hrs.	Local	UTC
--	Forward	Amidships	Aft
Port			
Starboard			
List of Heel		Degrees	P S
2. Approximate Area of Ground Contact			
Outline the approx. contact area on the hull outline.			
3. Provide water depths (W.D.)			
Water depth values to the extent needed.			
Measured by a boat or tug?			
Measured from ship's deck?			
4. Vessel Heading			
			-Degrees (T)

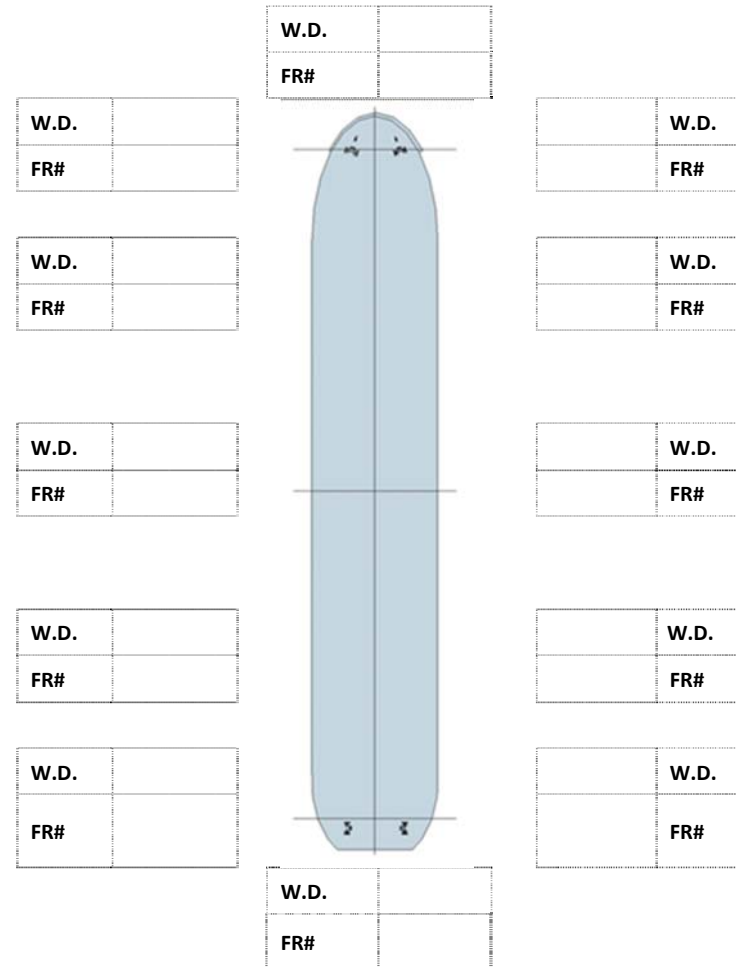
Additional Details About a Grounding Incident

Vessel Name:			
Date:			
5. Drafts - Aground			
Units	Meters	Feet	
Time	-hrs.	Local	UTC
--	Forward	Amidships	Aft
Port			
Starboard			
List of Heel		Degrees	P S
6. Approximate Area of Ground Contact			
Outline the approx. contact area on the hull outline.			
7. Provide water depths (W.D.)			
Water depth values to the extent needed.			
Measured by a boat or tug?			
Measured from ship's deck?			
8. Vessel Heading			
-Degrees (T)

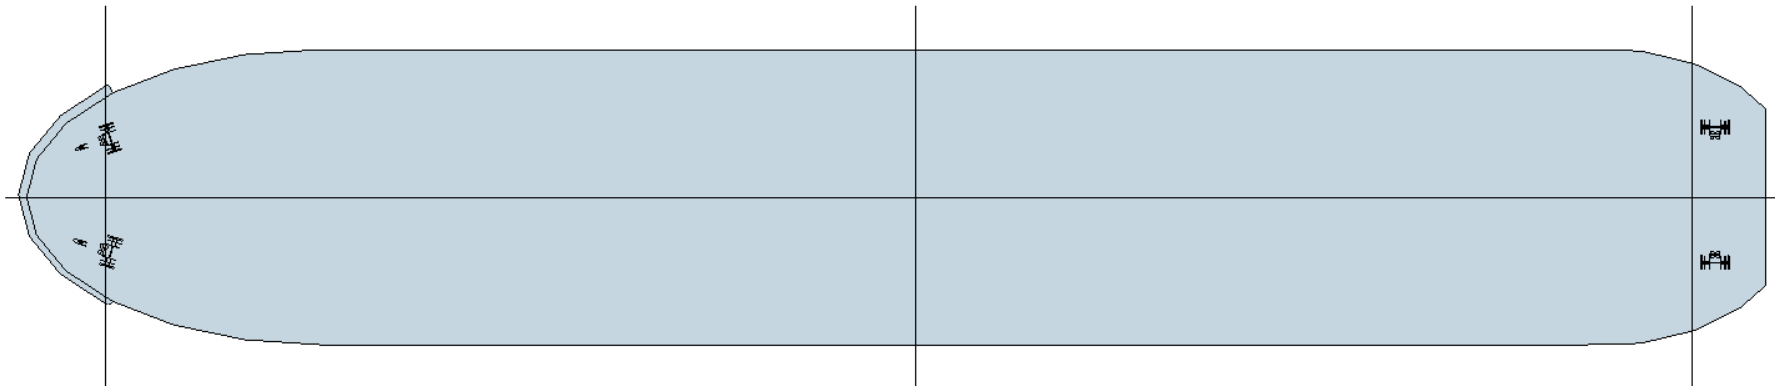
Handy Sketch for Any Incident

USE THIS DIAGRAM TO ILLUSTRATE ANY ADDITIONAL PERTINENT INFORMATION LIKE GROUND CONTACT AREA, PINNACLES, AREA DAMAGED, BUCKLING or CRACKS, HULL BREACH, WATER DEPTHS, FREEBOARDS, DRAFTS, OBSTRUCTIONS, ETC.

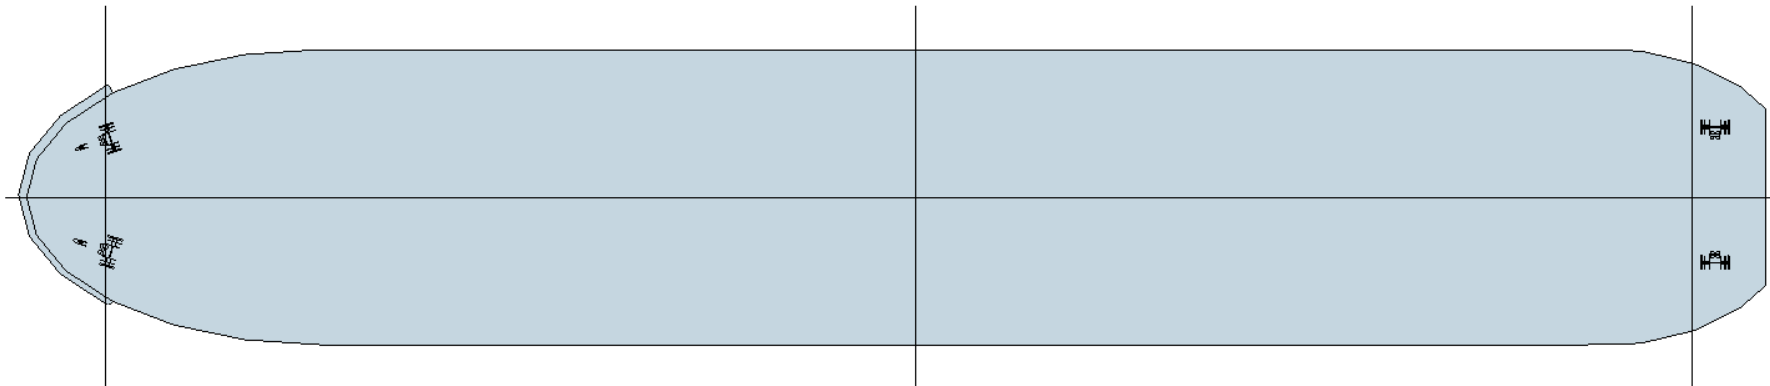
USE THIS DIAGRAM TO ILLUSTRATE ANY ADDITIONAL PERTINENT INFORMATION LIKE GROUND CONTACT AREA, PINNACLES, AREA DAMAGED, BUCKLING or CRACKS, HULL BREACH, WATER DEPTHS, FREEBOARDS, DRAFTS, OBSTRUCTIONS, ETC.
