USER MANUAL  
Tug-Barge  
Combination

RAPID  
RESPONSE  
DAMAGE  
ASSESSMENT

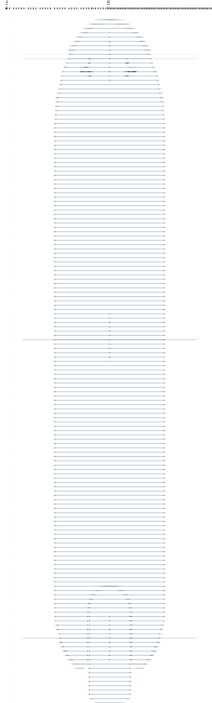
<b>Vessel Name:</b>			
<b>Date:</b>			
<b>1. Drafts - Aground</b>			
<b>Units</b>	Meters	Feet	
<b>Time</b>	-hrs.	Local	UTC
--	Forward	Amidships	Aft
<b>Port</b>			
<b>Starboard</b>			
<b>List or Heel</b>		Degrees	P S
<b>2. Approximate Area of Ground Contact</b>			
Outline the approx. contact area on the hull outline.			
<b>3. Provide water depths (W.D.)</b>			
Water depth values to the extent needed.			
Measured by a boat or tug?			
Measured from ship's deck?			
<b>4. Vessel Heading</b>			
			-Degrees (T)

<b>W.D.</b>		<b>W.D.</b>	
<b>FR#</b>		<b>FR#</b>	
<b>W.D.</b>		<b>W.D.</b>	
<b>FR#</b>		<b>FR#</b>	
<b>W.D.</b>		<b>W.D.</b>	
<b>FR#</b>		<b>FR#</b>	
<b>W.D.</b>		<b>W.D.</b>	
<b>FR#</b>		<b>FR#</b>	
<b>W.D.</b>		<b>W.D.</b>	
<b>FR#</b>		<b>FR#</b>

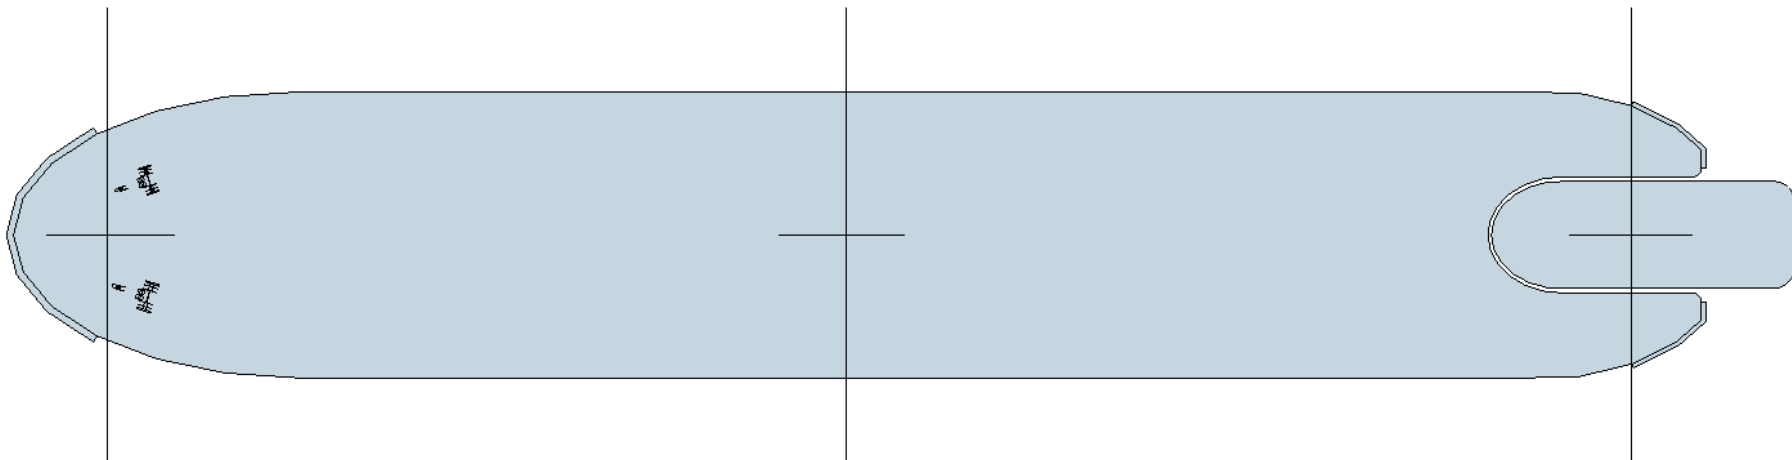
Handy Sketch for Any Incident

USE THIS DIAGRAM TO ILLUSTRATE ANY ADDITIONAL PERTINENT INFORMATION LIKE GROUND CONTACT AREA, PINNACLES, AREA DAMAGED, BUCKLING or CRACKS, HULL BREACH, WATER DEPTHS, FREEBOARDS, DRAFTS, OBSTRUCTIONS, ETC.

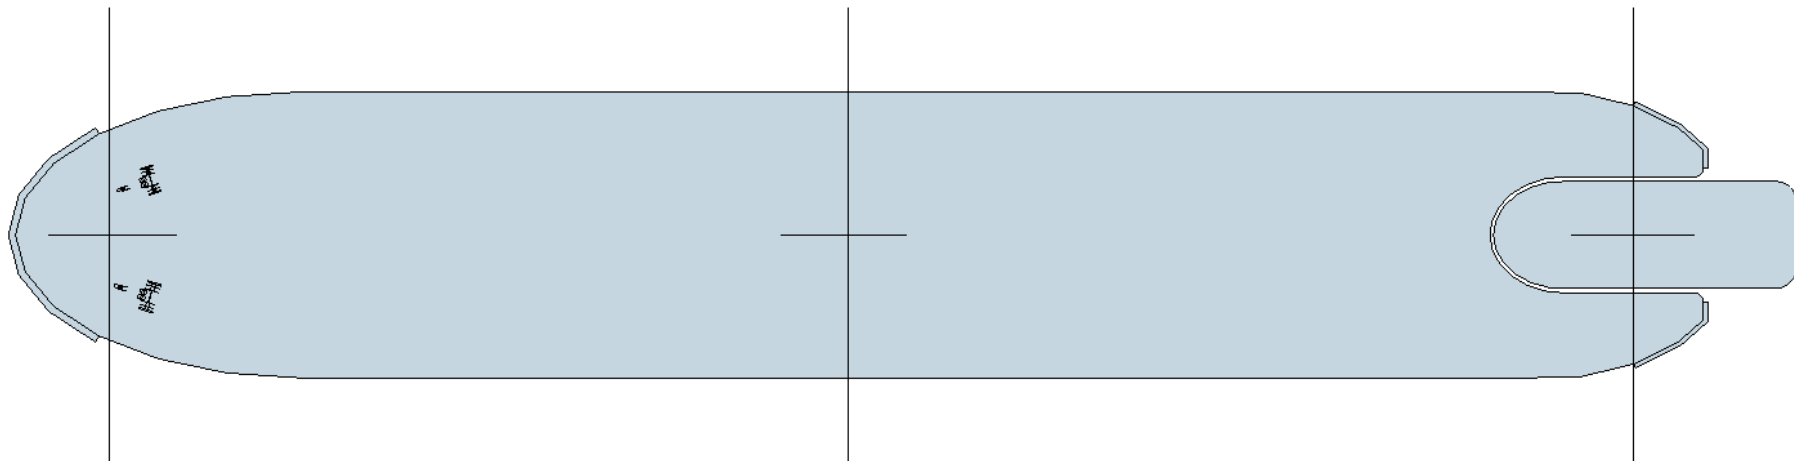
USE THIS DIAGRAM TO ILLUSTRATE ANY ADDITIONAL PERTINENT INFORMATION LIKE GROUND CONTACT AREA, PINNACLES, AREA DAMAGED, BUCKLING or CRACKS, HULL BREACH, WATER DEPTHS, FREEBOARDS, DRAFTS, OBSTRUCTIONS, ETC.
