USER MANUAL Tug-Barge Combination

RAPID RESPONSE DAMAGE ASSESSMENT

March 2019

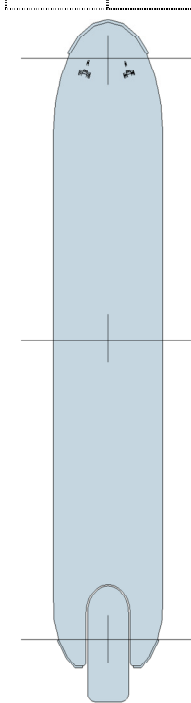
Vessel Name:			
Date:			
1. Drafts - Aground			
Units	Meters	Feet	
Time	-hrs.	Local	UTC
--	Forward	Amidships	Aft
Port			
Starboard			
List or Heel		Degrees	P S
2. Approximate Area of Ground Contact			
Outline the approx. contact area on the hull outline.			
3. Provide water depths (W.D.)			
Water depth values to the extent needed.			
Measured by a boat or tug?			
Measured from ship's deck?			
4. Vessel Heading			
-Degrees (T)

W.D.		W.D.	
FR#		FR#	
W.D.		W.D.	
FR#		FR#	
W.D.		W.D.	
FR#		FR#	
W.D.		W.D.	
FR#		FR#	
W.D.		W.D.	
FR#		FR#

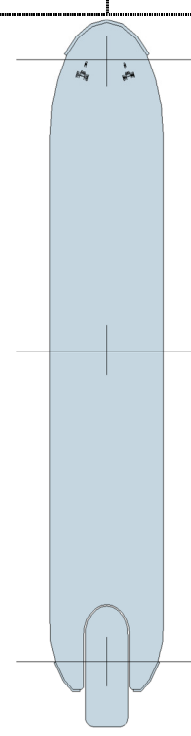
Additional Details About a Grounding Incident

Vessel Name:			
Date:			
5. Drafts - Aground			
Units	Meters	Feet	
Time	-hrs.	Local	UTC
--	Forward	Amidships	Aft
Port			
Starboard			
List or Heel		Degrees	P S
6. Approximate Area of Ground Contact			
Outline the approx. contact area on the hull outline.			
7. Provide water depths (W.D.)			
Water depth values to the extent needed.			
Measured by a boat or tug?			
Measured from ship's deck?			
8. Vessel Heading			
-Degrees (T)

W.D.			
FR#			
W.D.			W.D.
FR#			FR#
W.D.			W.D.
FR#			FR#
W.D.			W.D.
FR#			FR#
W.D.			W.D.
FR#			FR#
W.D.			W.D.
FR#			FR#

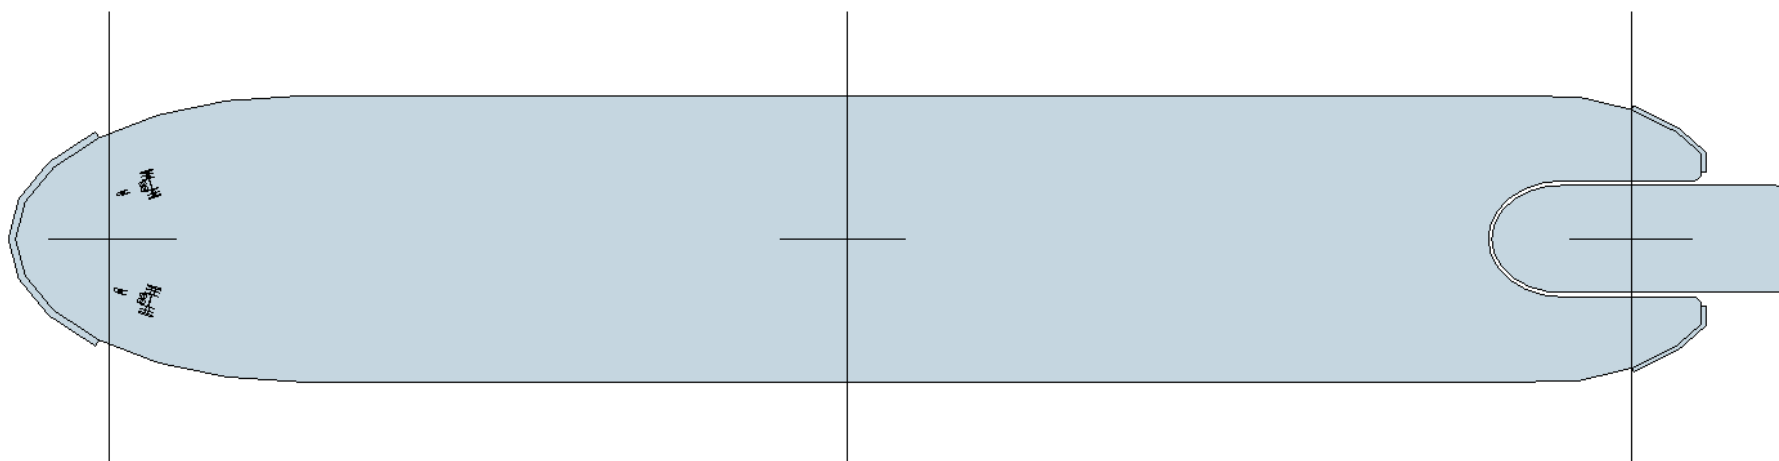
Handy Sketch for Any Incident

USE THIS DIAGRAM TO ILLUSTRATE ANY ADDITIONAL PERTINENT INFORMATION LIKE GROUND CONTACT AREA, PINNICLES, AREA DAMAGED, BUCKLING or CRACKS, HULL BREACH, WATER DEPTHS, FREEBOARDS, DRAFTS, OBSTRUCTIONS, ETC.

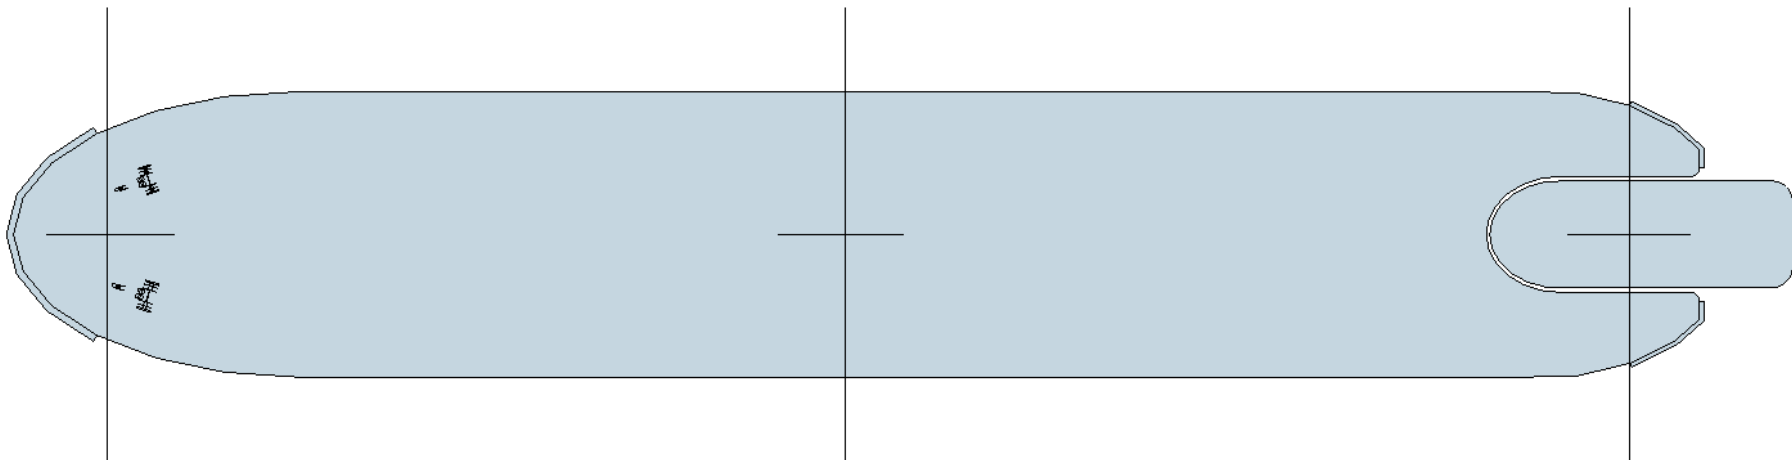
USE THIS DIAGRAM TO ILLUSTRATE ANY ADDITIONAL PERTINENT INFORMATION LIKE GROUND CONTACT AREA, PINNICLES, AREA DAMAGED, BUCKLING or CRACKS, HULL BREACH, WATER DEPTHS, FREEBOARDS, DRAFTS, OBSTRUCTIONS, ETC.
