USER MANUAL – GAS CARRIER

RAPID RESPONSE DAMAGE ASSESSMENT

February 23, 2021

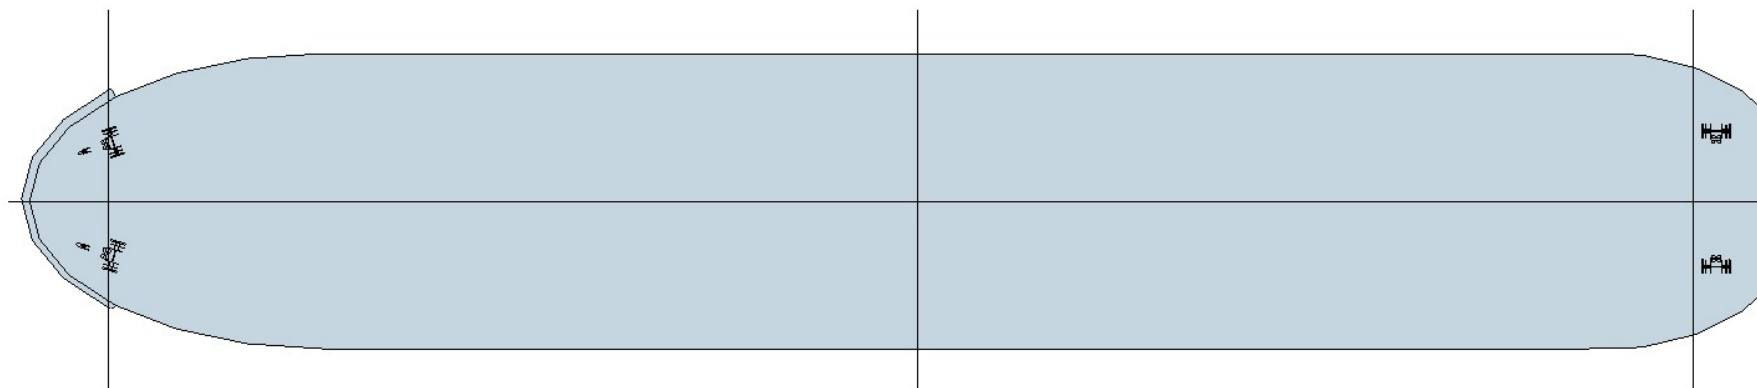
USE THIS DIAGRAM TO ILLUSTRATE ANY ADDITIONAL PERTINENT INFORMATION LIKE GROUND CONTACT AREA, PINNICLES, AREA DAMAGED, BUCKLING or CRACKS, HULL BREACH, WATER DEPTHS, FREEBOARDS, DRAFTS, OBSTRUCTIONS, ETC.
