USER MANUAL
Offshore Service
Vessel

RAPID
RESPONSE
DAMAGE
ASSESSMENT

September 2019

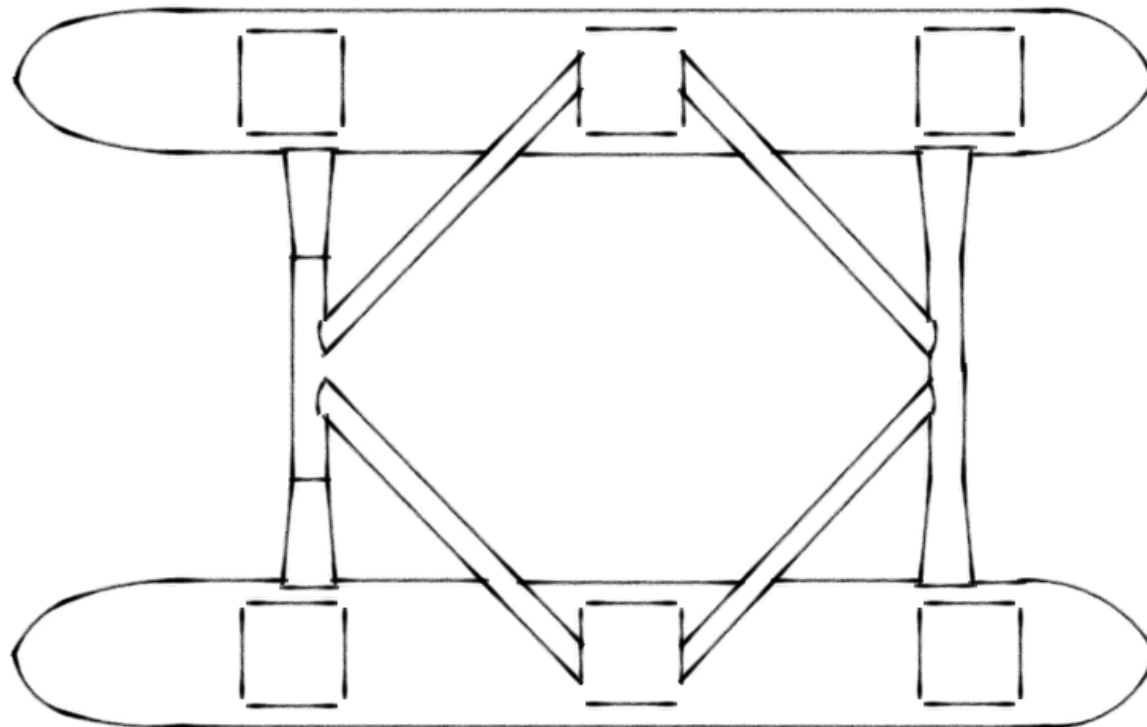
USE THIS DIAGRAM TO ILLUSTRATE ANY ADDITIONAL PERTINENT INFORMATION LIKE GROUND CONTACT AREA, PINNICLES, AREA DAMAGED, BUCKLING or CRACKS, HULL BREACH, WATER DEPTHS, FREEBOARDS, DRAFTS, OBSTRUCTIONS, ETC.
