USER MANUAL – TANKER

RAPID
RESPONSE
DAMAGE
ASSESSMENT

September 2019

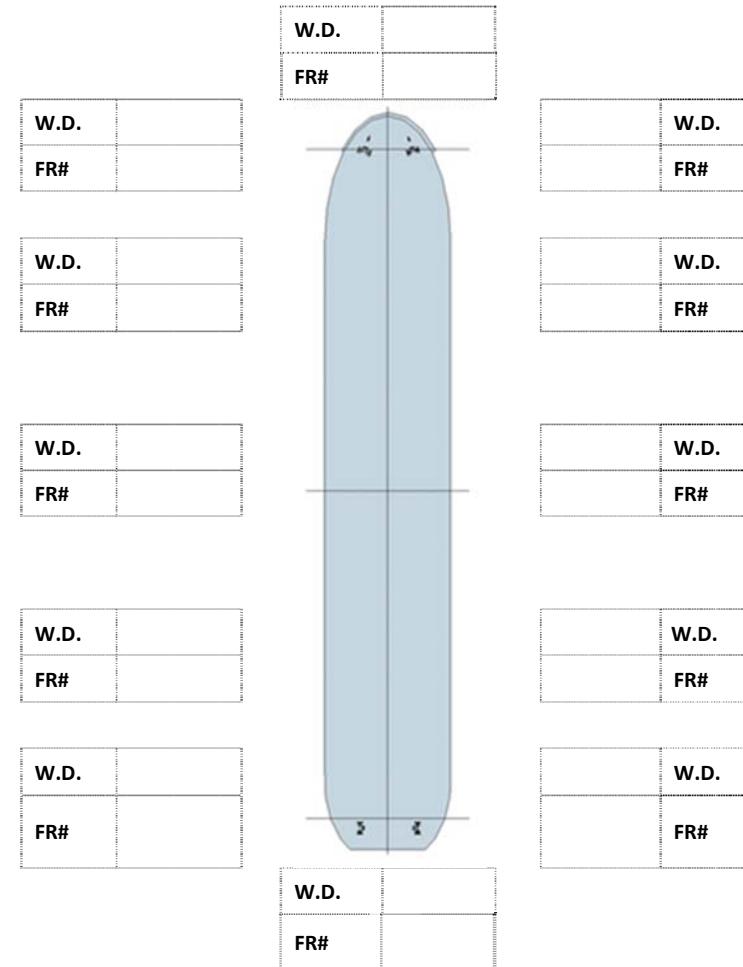
Additional Details About a Grounding Incident

Vessel Name:		
Date:		
1. Drafts - Aground		
Units	Meters	Feet
Time	-hrs.	Local UTC
--	Forward	Amidships Aft
Port		
Starboard		
List of Heel	Degrees	P S
2. Approximate Area of Ground Contact		
Outline the approx. contact area on the hull outline.		
3. Provide water depths (W.D.)		
Water depth values to the extent needed.		
Measured by a boat or tug?		
Measured from ship's deck?		
4. Vessel Heading		
-Degrees (T)

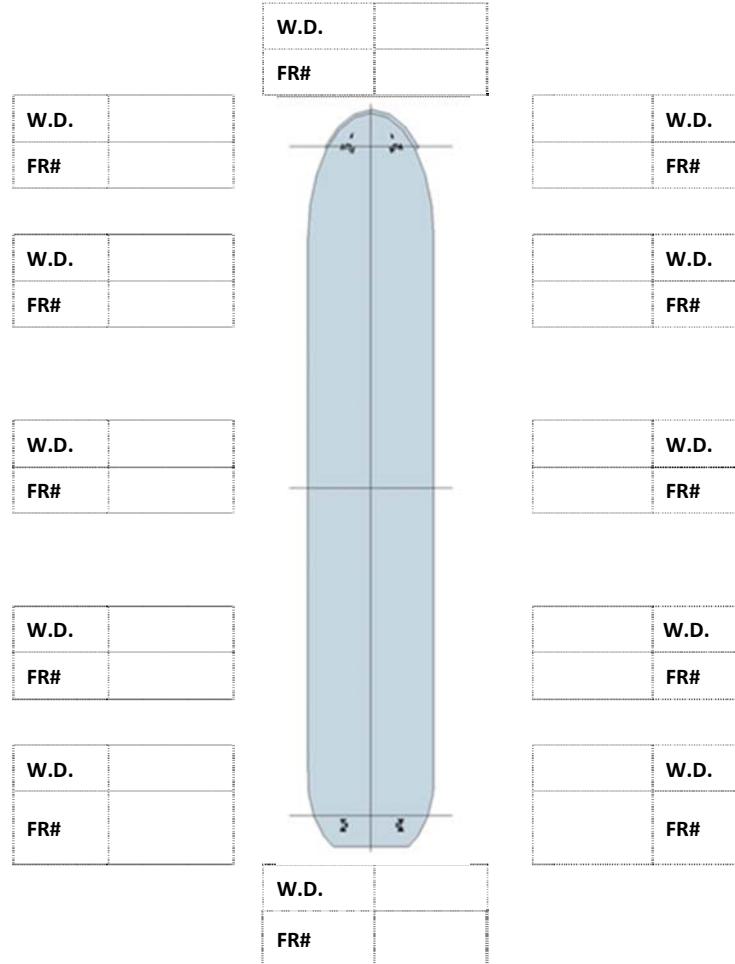
Additional Details About a Grounding Incident

8. Vessel Heading

-Degrees (T)

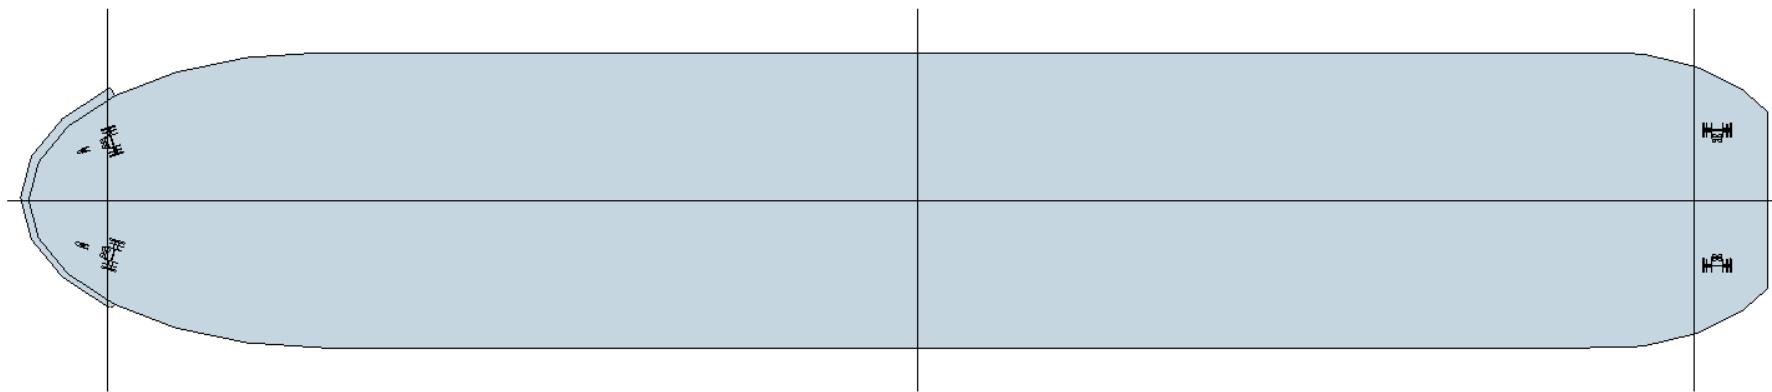
Handy Sketch for Any Incident

USE THIS DIAGRAM TO ILLUSTRATE ANY ADDITIONAL PERTINENT INFORMATION LIKE GROUND CONTACT AREA, PINNICLES, AREA DAMAGED, BUCKLING or CRACKS, HULL BREACH, WATER DEPTHS, FREEBOARDS, DRAFTS, OBSTRUCTIONS, ETC.

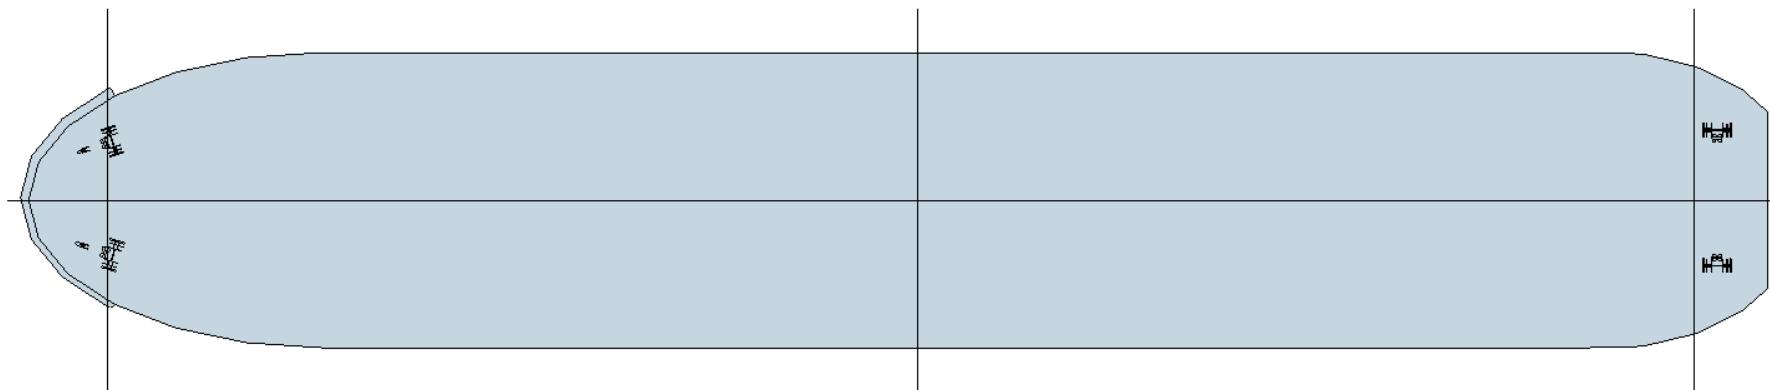
USE THIS DIAGRAM TO ILLUSTRATE ANY ADDITIONAL PERTINENT INFORMATION LIKE GROUND CONTACT AREA, PINNICLES, AREA DAMAGED, BUCKLING or CRACKS, HULL BREACH, WATER DEPTHS, FREEBOARDS, DRAFTS, OBSTRUCTIONS, ETC.
