2019 Best Practices for Operations of Ballast Water Management Systems Report

American Bureau of Shipping
Advisory Services

Date: 18 March 2019

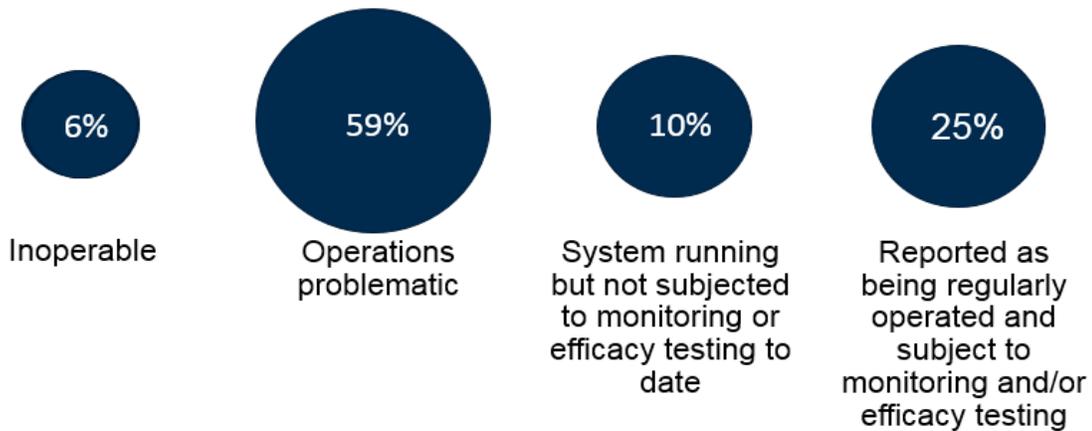
Figure 1 BWMS Operability

When analyzing the 2018 survey results, ABS found that 35% of the 483 BWMS installations were reported as operating regularly, and the remaining systems were either inoperable or considered problematic.

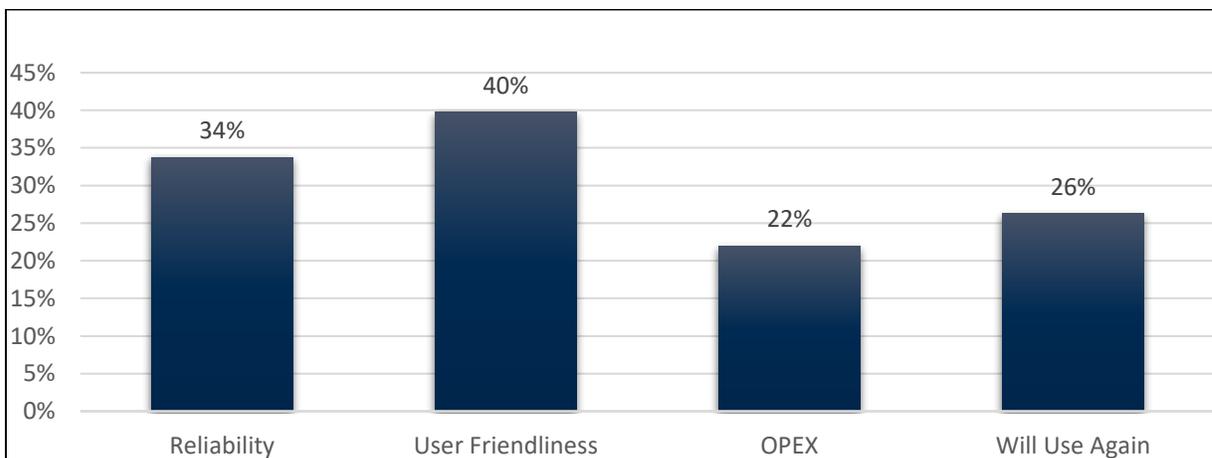
Figure 2 BWMS Overall Experience (Positive Feedback)

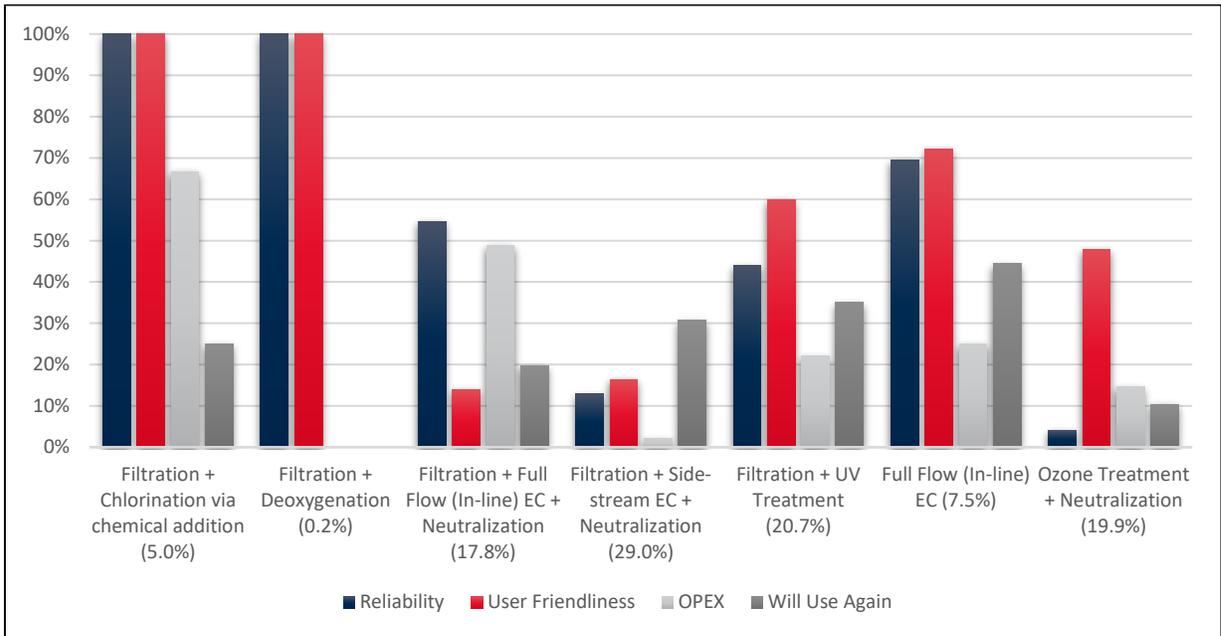
Figure 3 BWMS Overall Experience-Treatment Technologies (Positive Feedback)

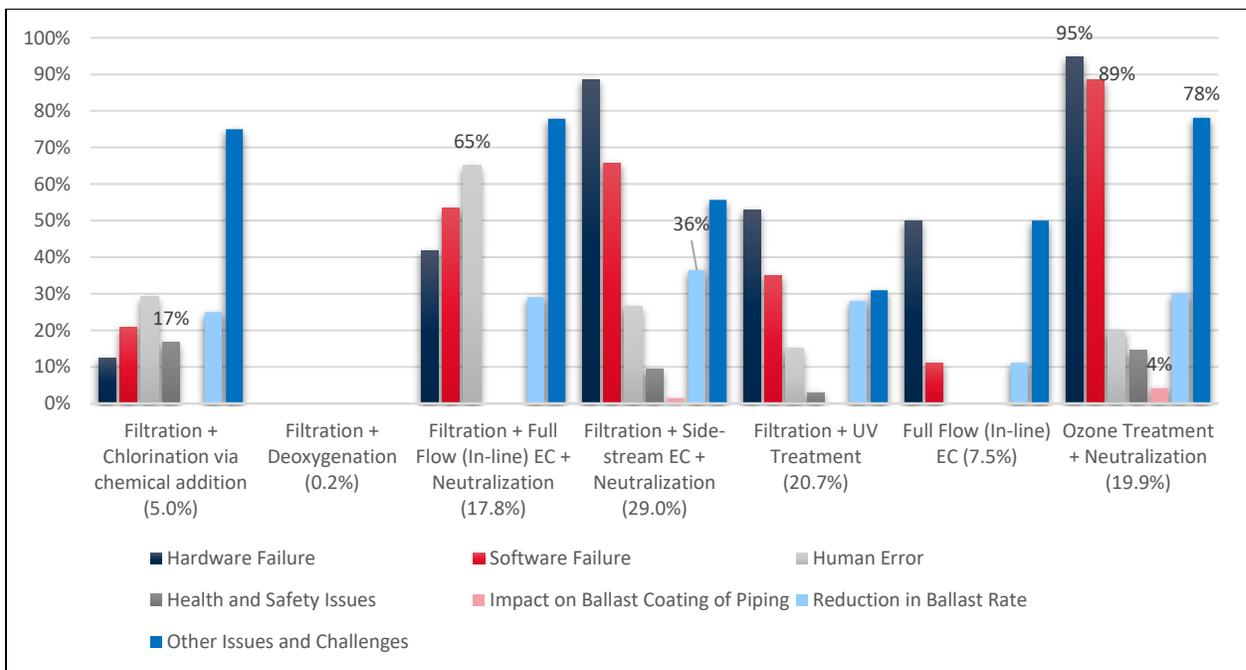
Figure 4 In-Operation Concerns Reported

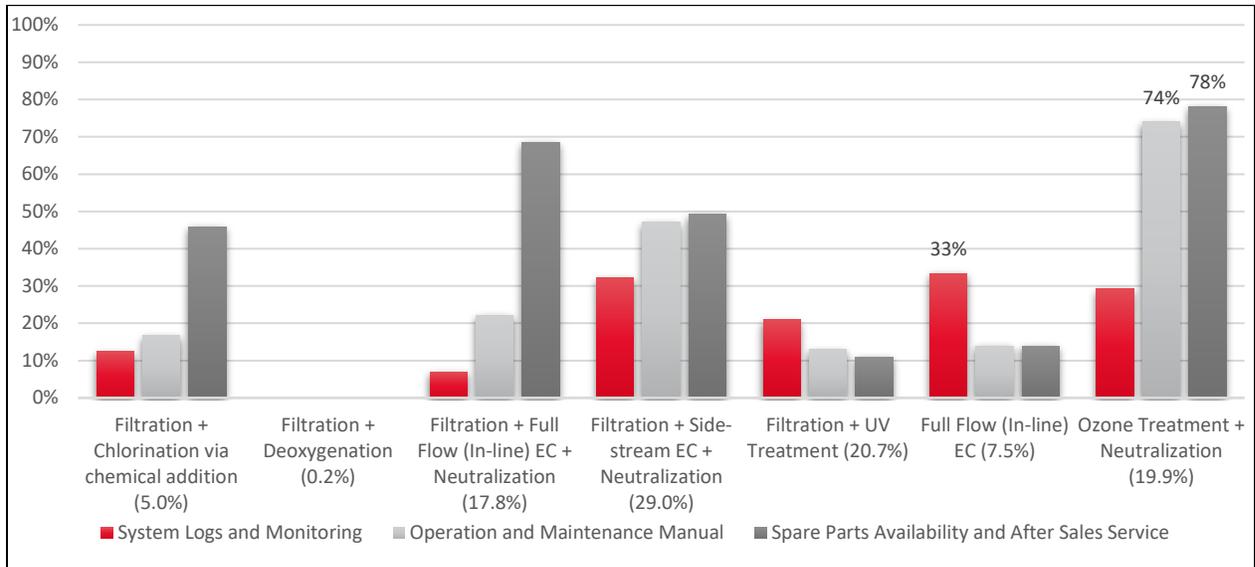
Figure 5 Maintenance Concerns Reported

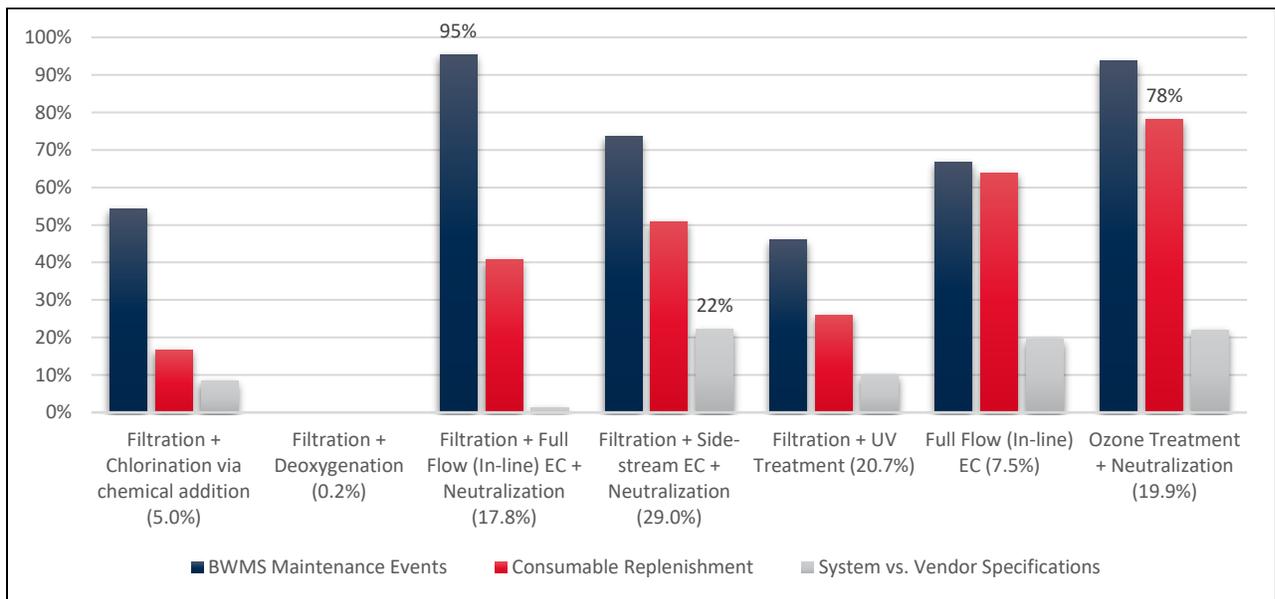
Figure 6 Post Operation Concerns Reported

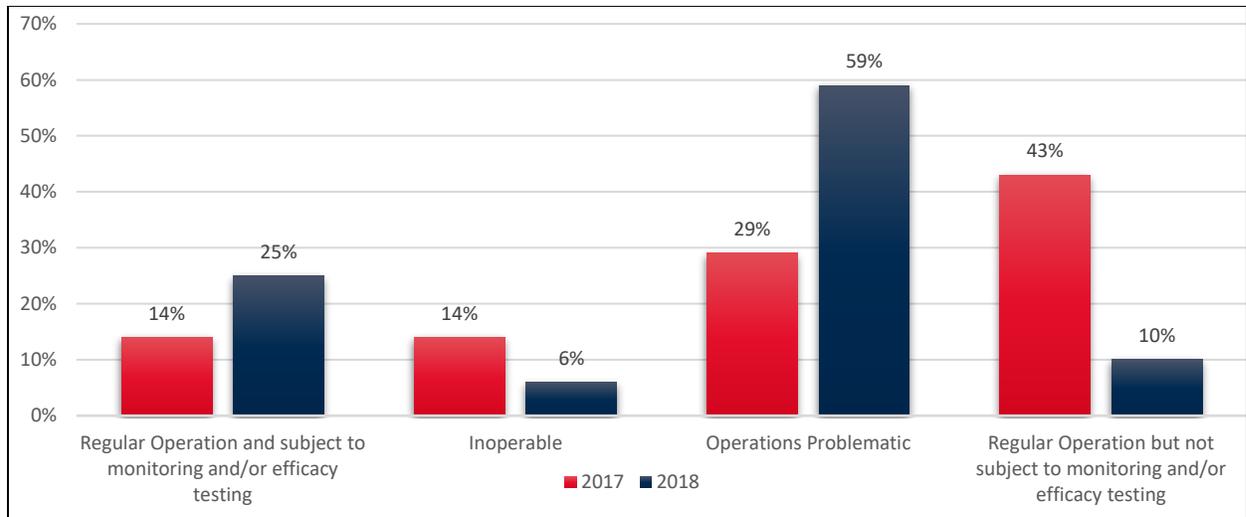
The survey findings represented in Figure 7 below show that the number of problematic BWMS in operation increased from 29% in 2017 to 59% in 2018. This implies that many vessel operators are trying to get their BWMS fully functional and into operation before the U.S. Coast Guard or IMO compliance deadlines.

Figure 7 BWMS Operability (2017 vs 2018)

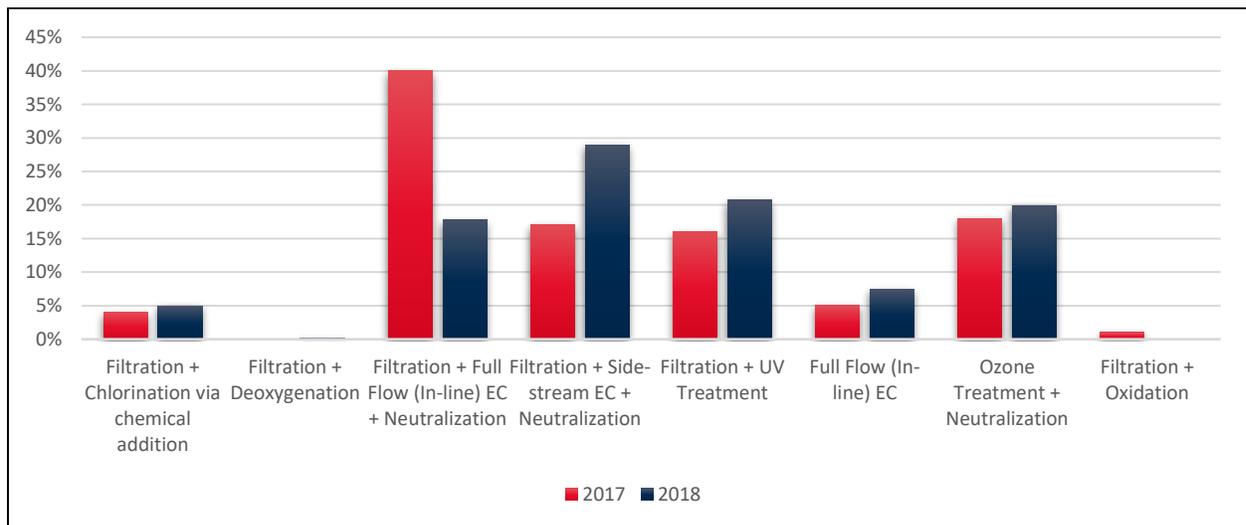
Figure 8 BWMS Technology Types (2017 vs 2018)

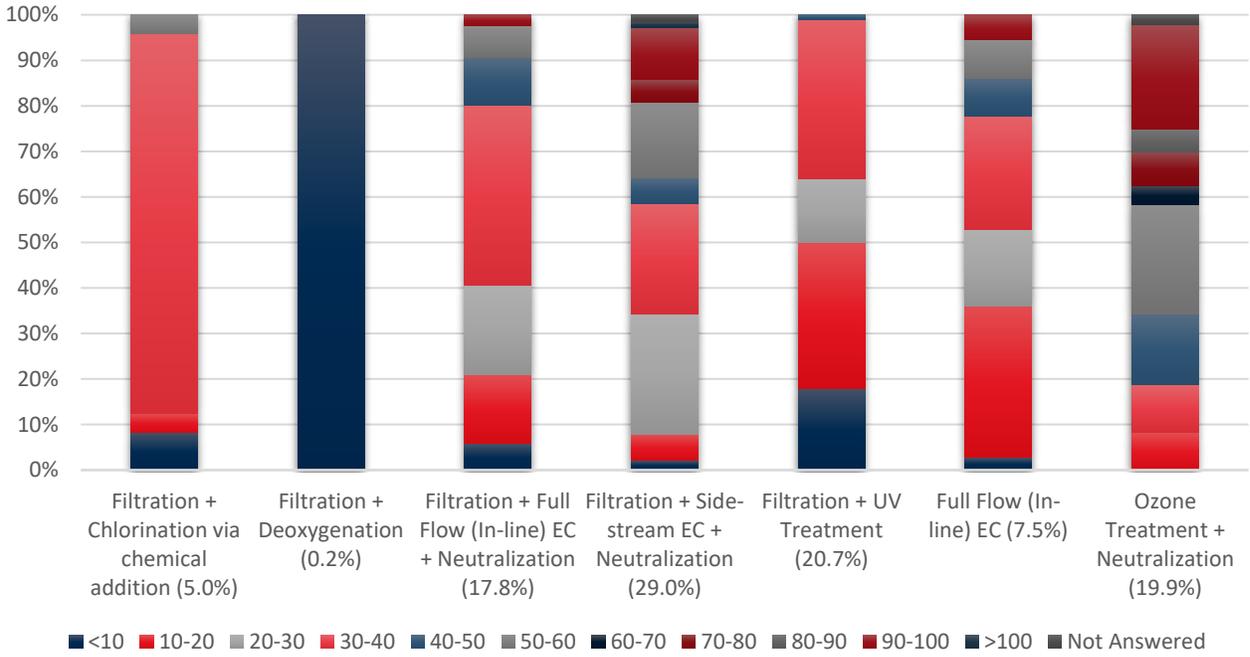
BWMS Technology Types vs. BW Capacity (10³ m³)

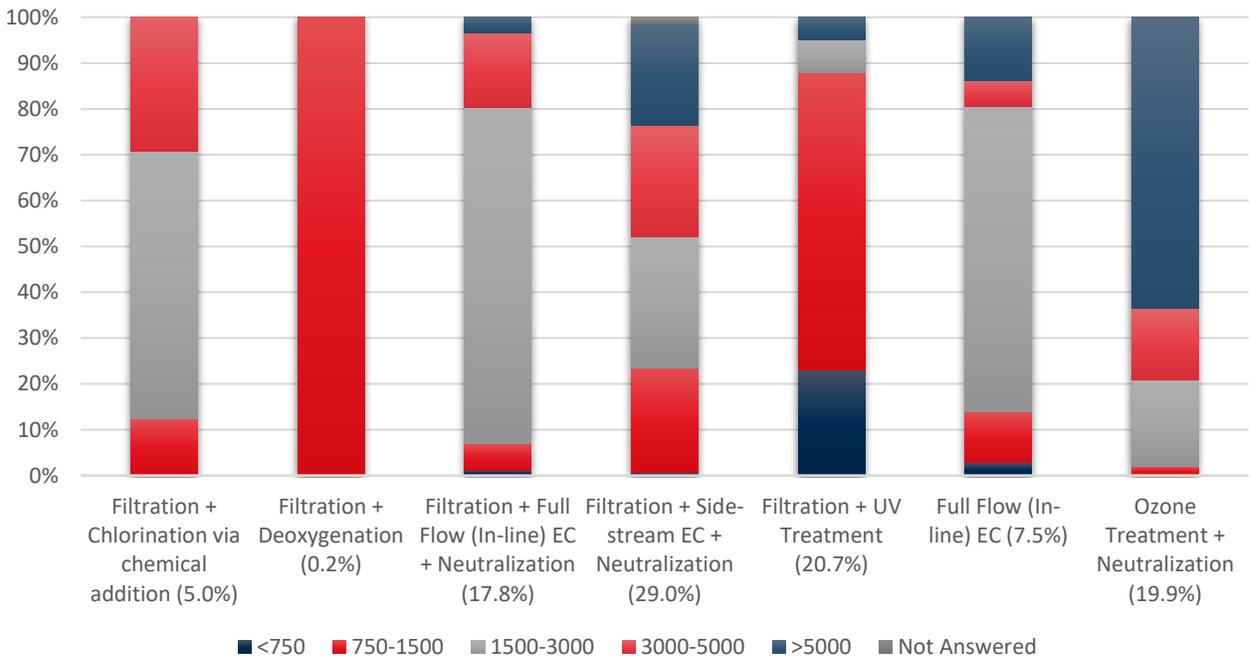
BWMS Technology Types vs. BW Pump Size (m³/Hour)

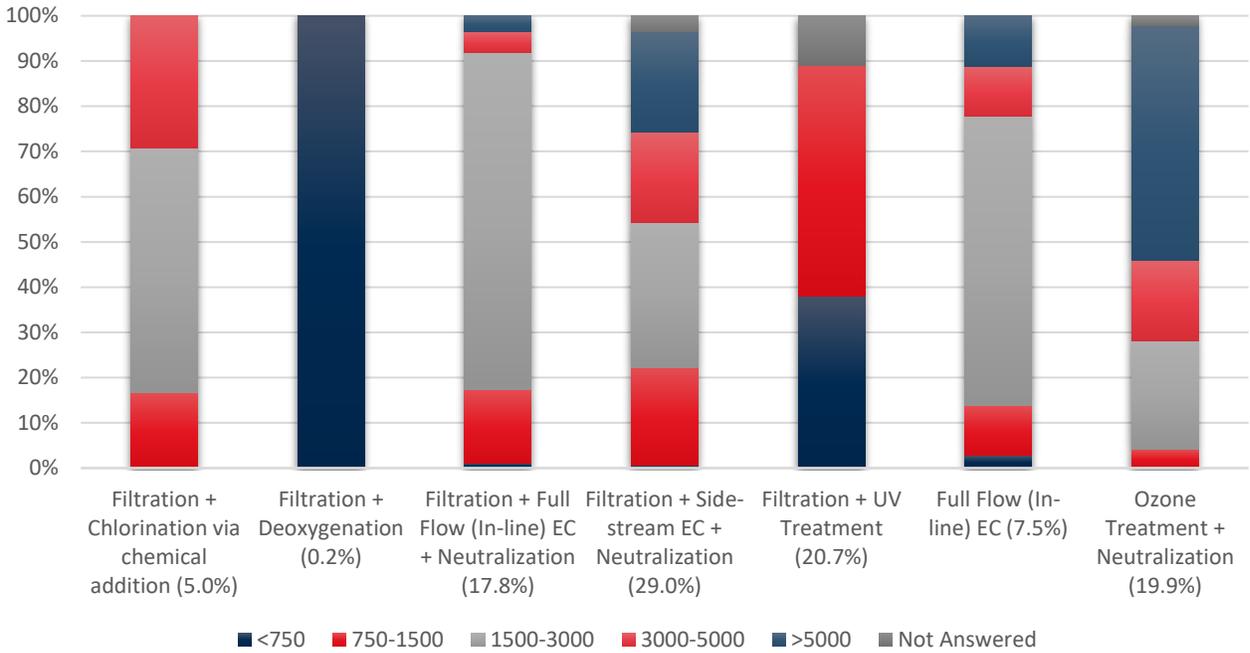
BWMS Technology Types vs. TRC (m³/Hour)

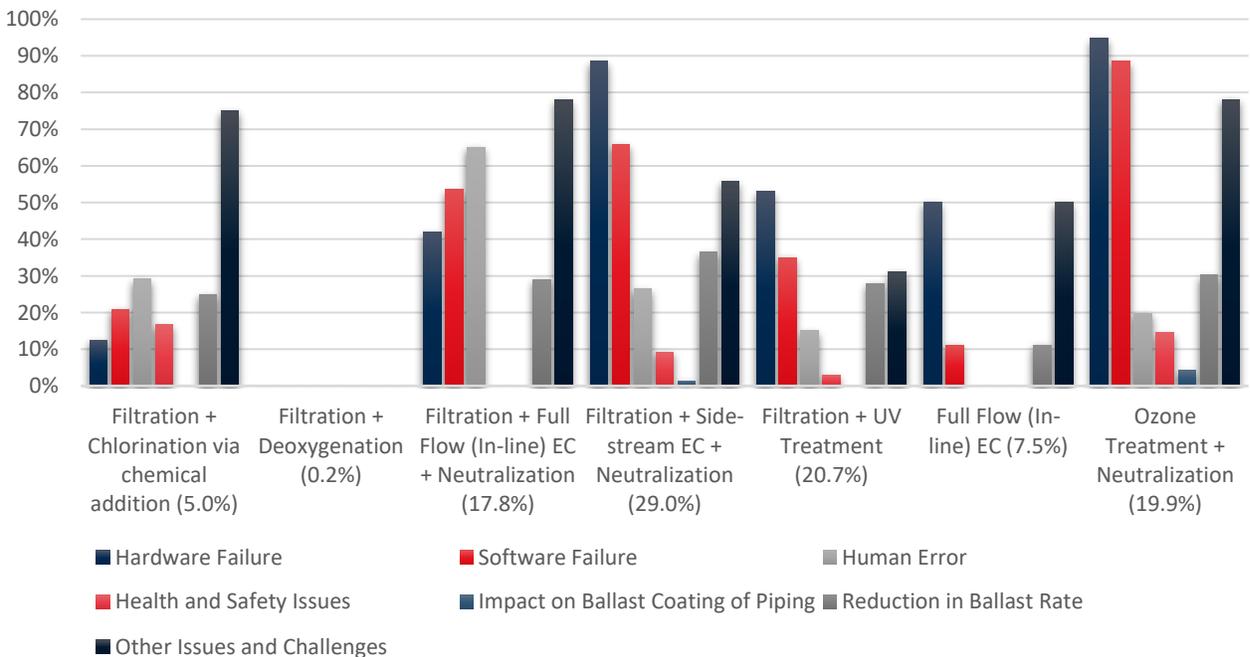
BWMS In-Operation Concerns Reported

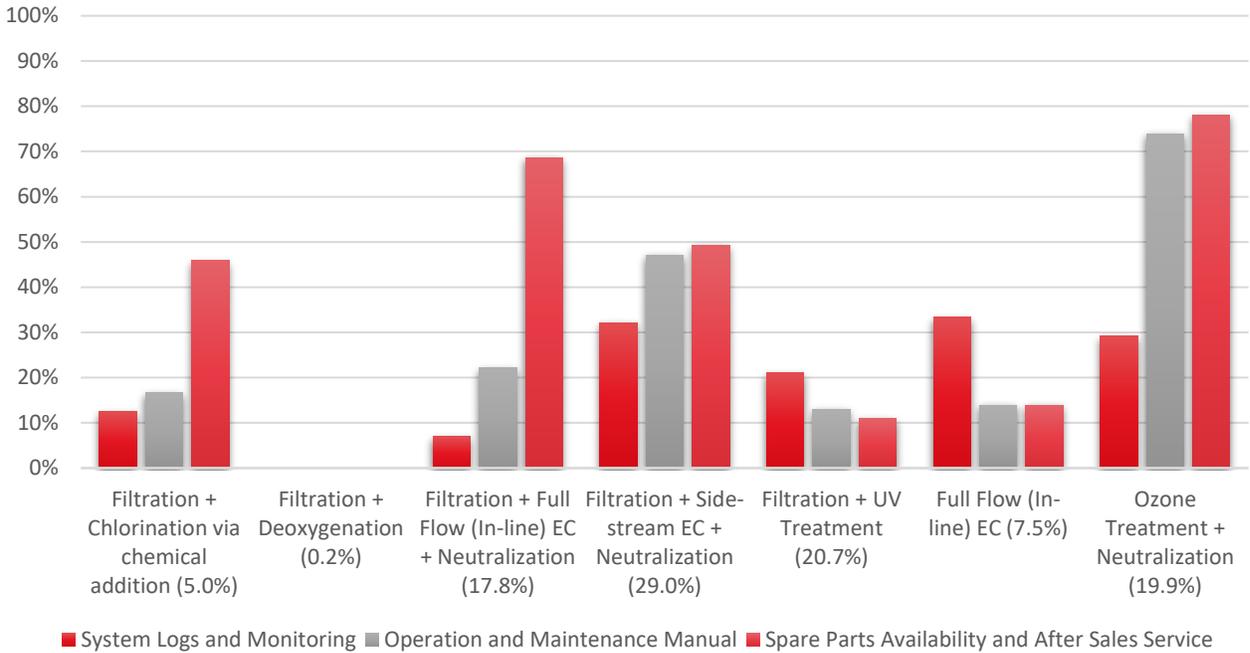
BWMS Maintenance Concerns Reported

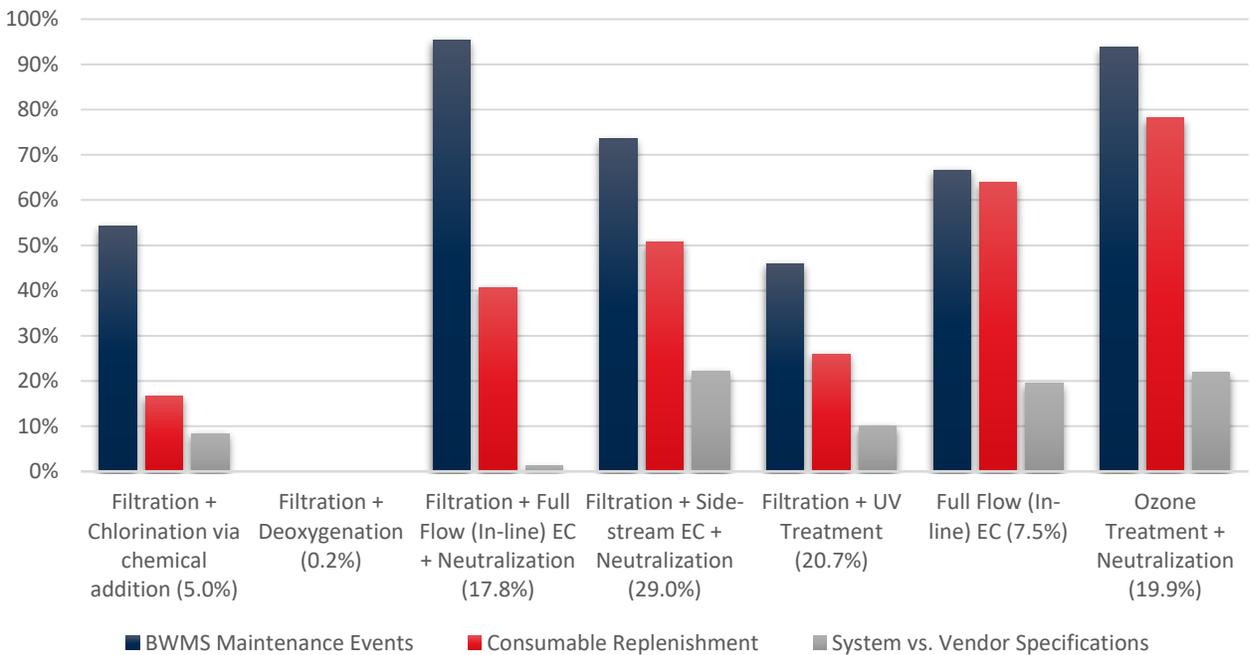
BWMS Post Operation Concerns Reported

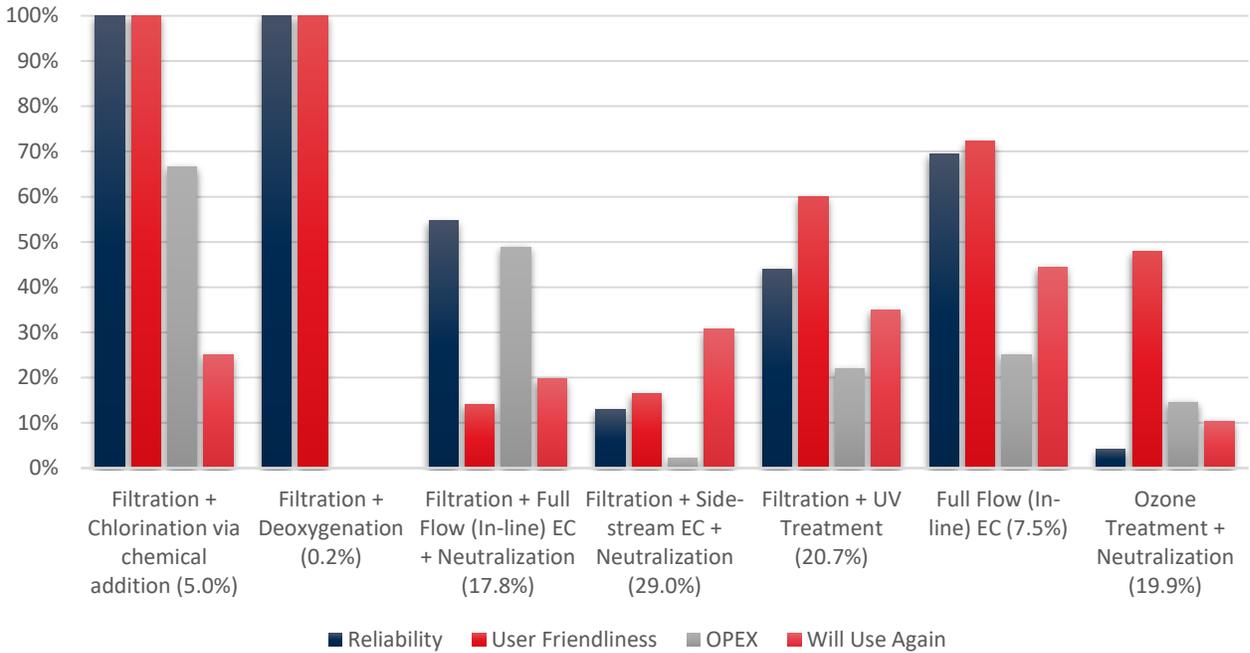
BWMS Overall Experience - Positive Feedback

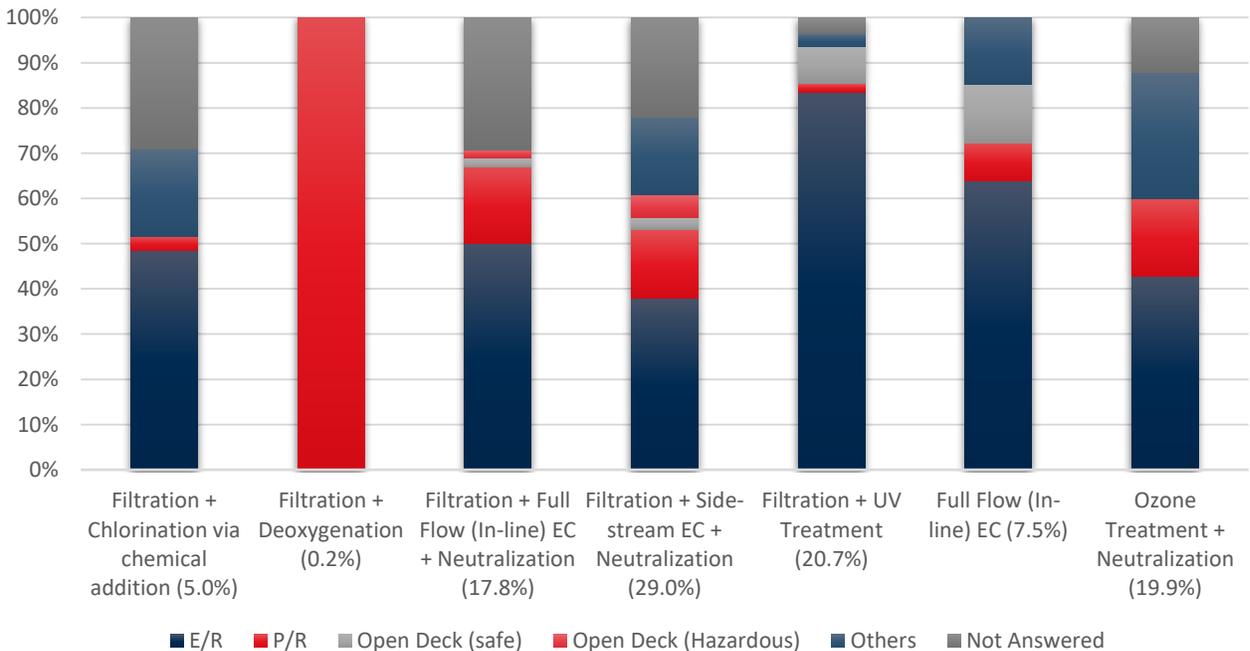
BWMS Technology Types vs. Installation Location

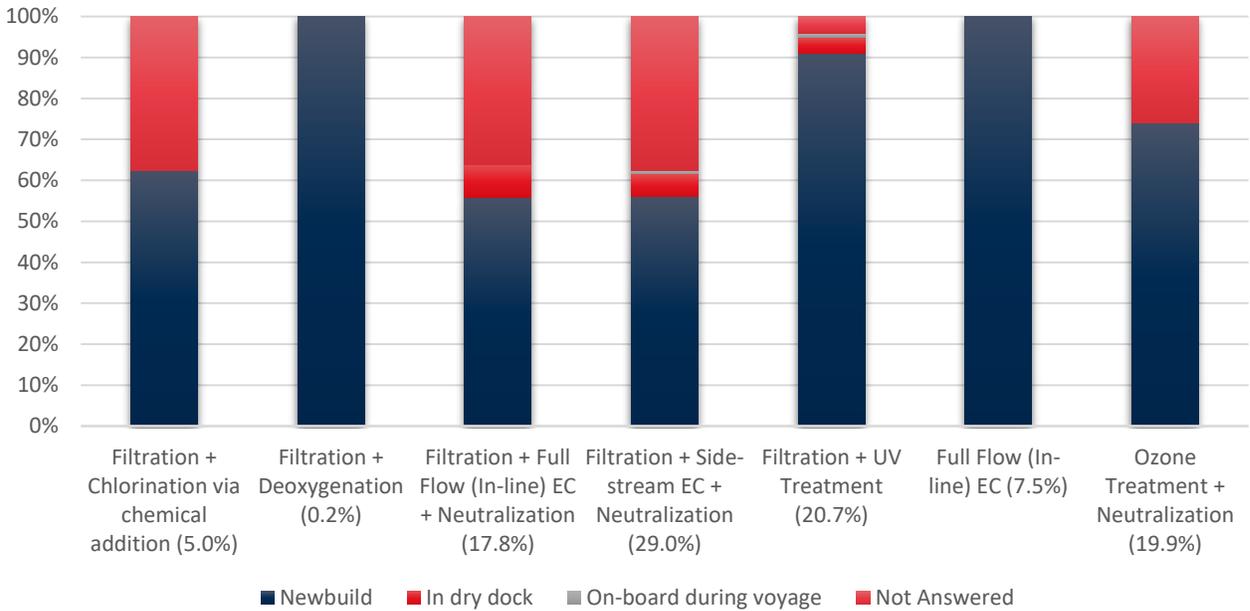
BWMS Technology Types vs. Site for Installation Work

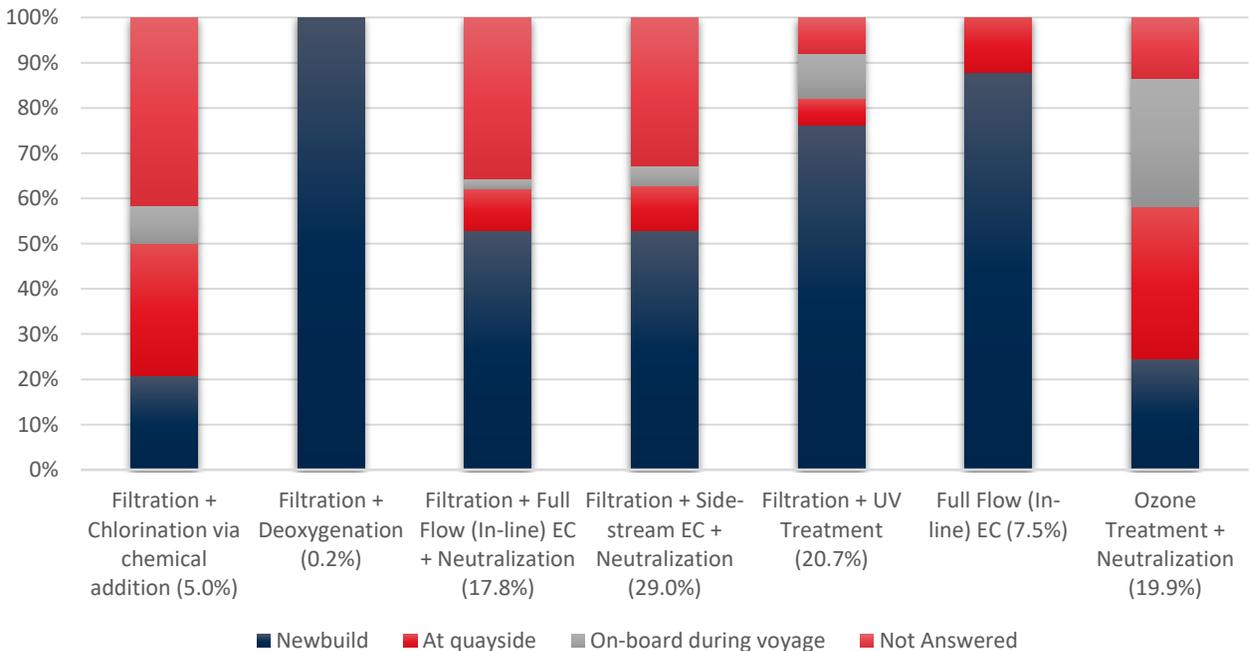
BWMS Technology Types vs. Commissioning Site

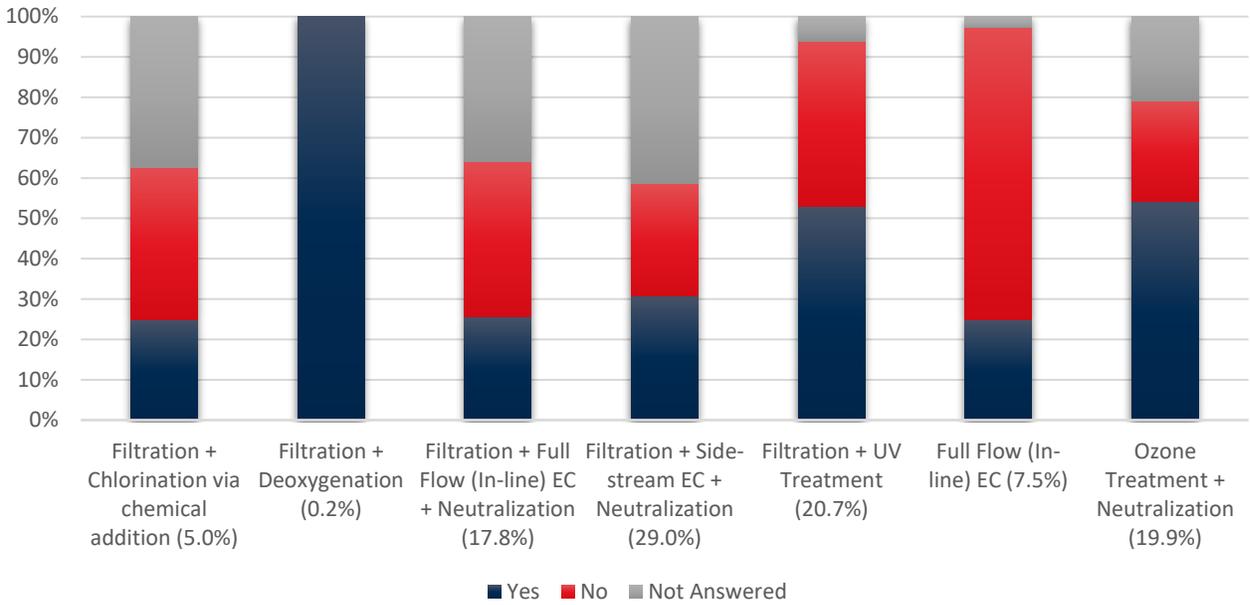
BWMS Technology Types vs. Shipboard Crew Involvement

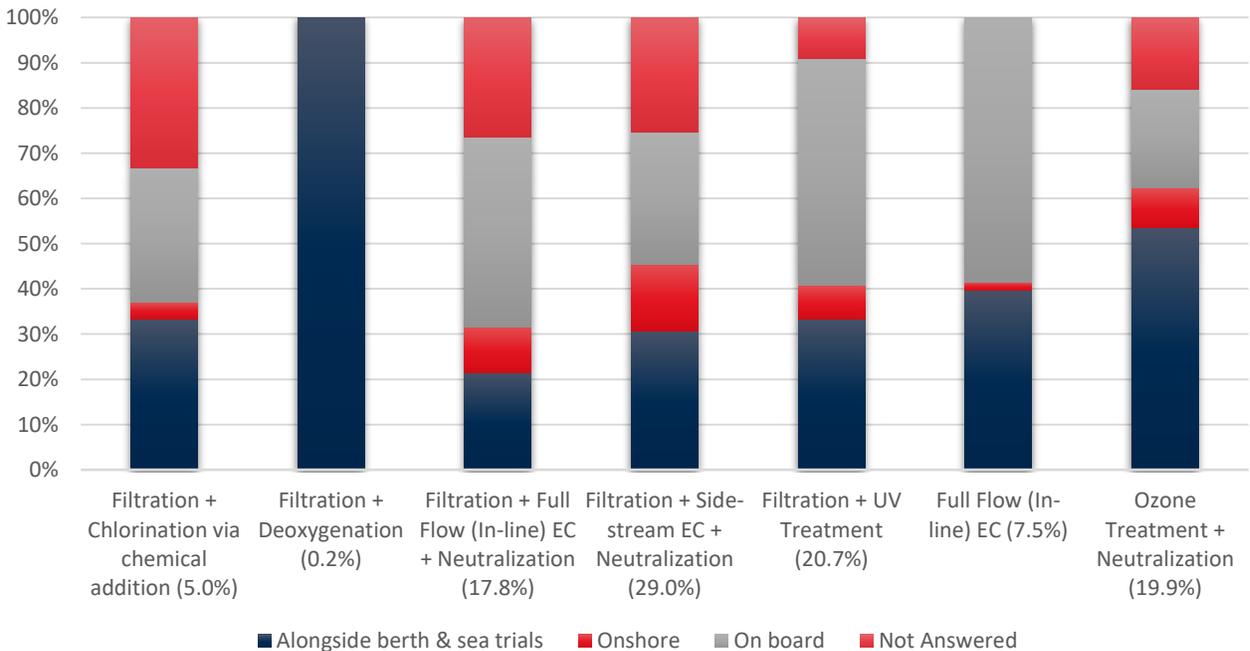
BWMS Technology Types vs. Crew Training Site

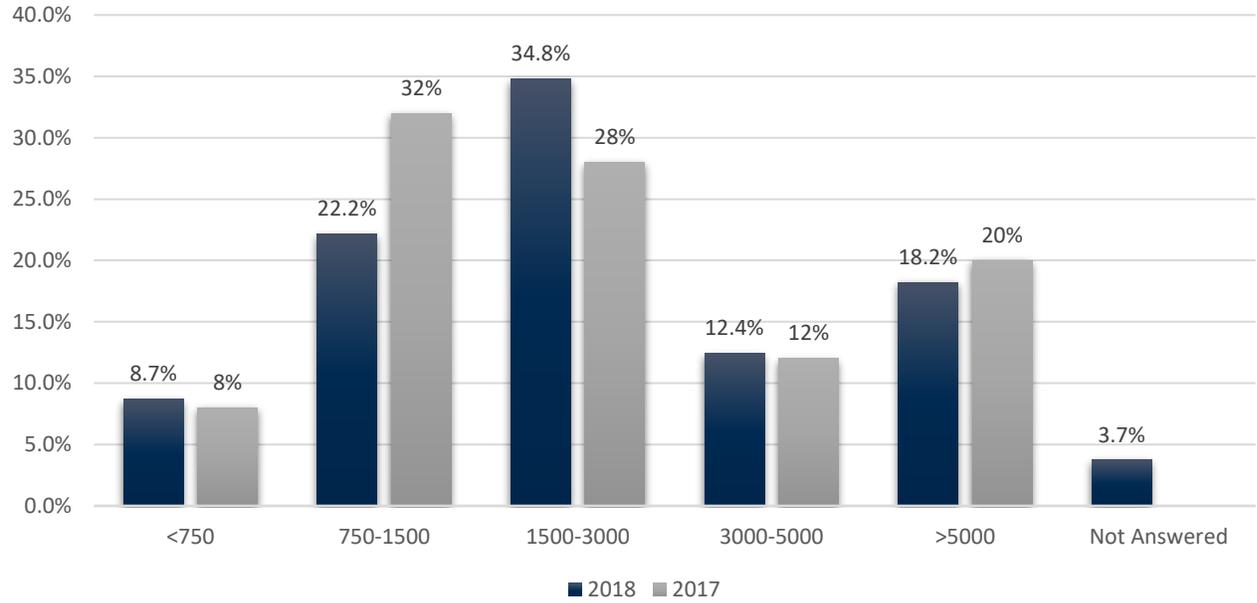
BWMS Treatment Rate Capacity (TRC) (m³/Hour)
